Hennessy Hall

# Carved Elements - Design Proposal

**Prepared by Scott Harris, FUNDY STONECRAFT**

**Jan 2, 2023**

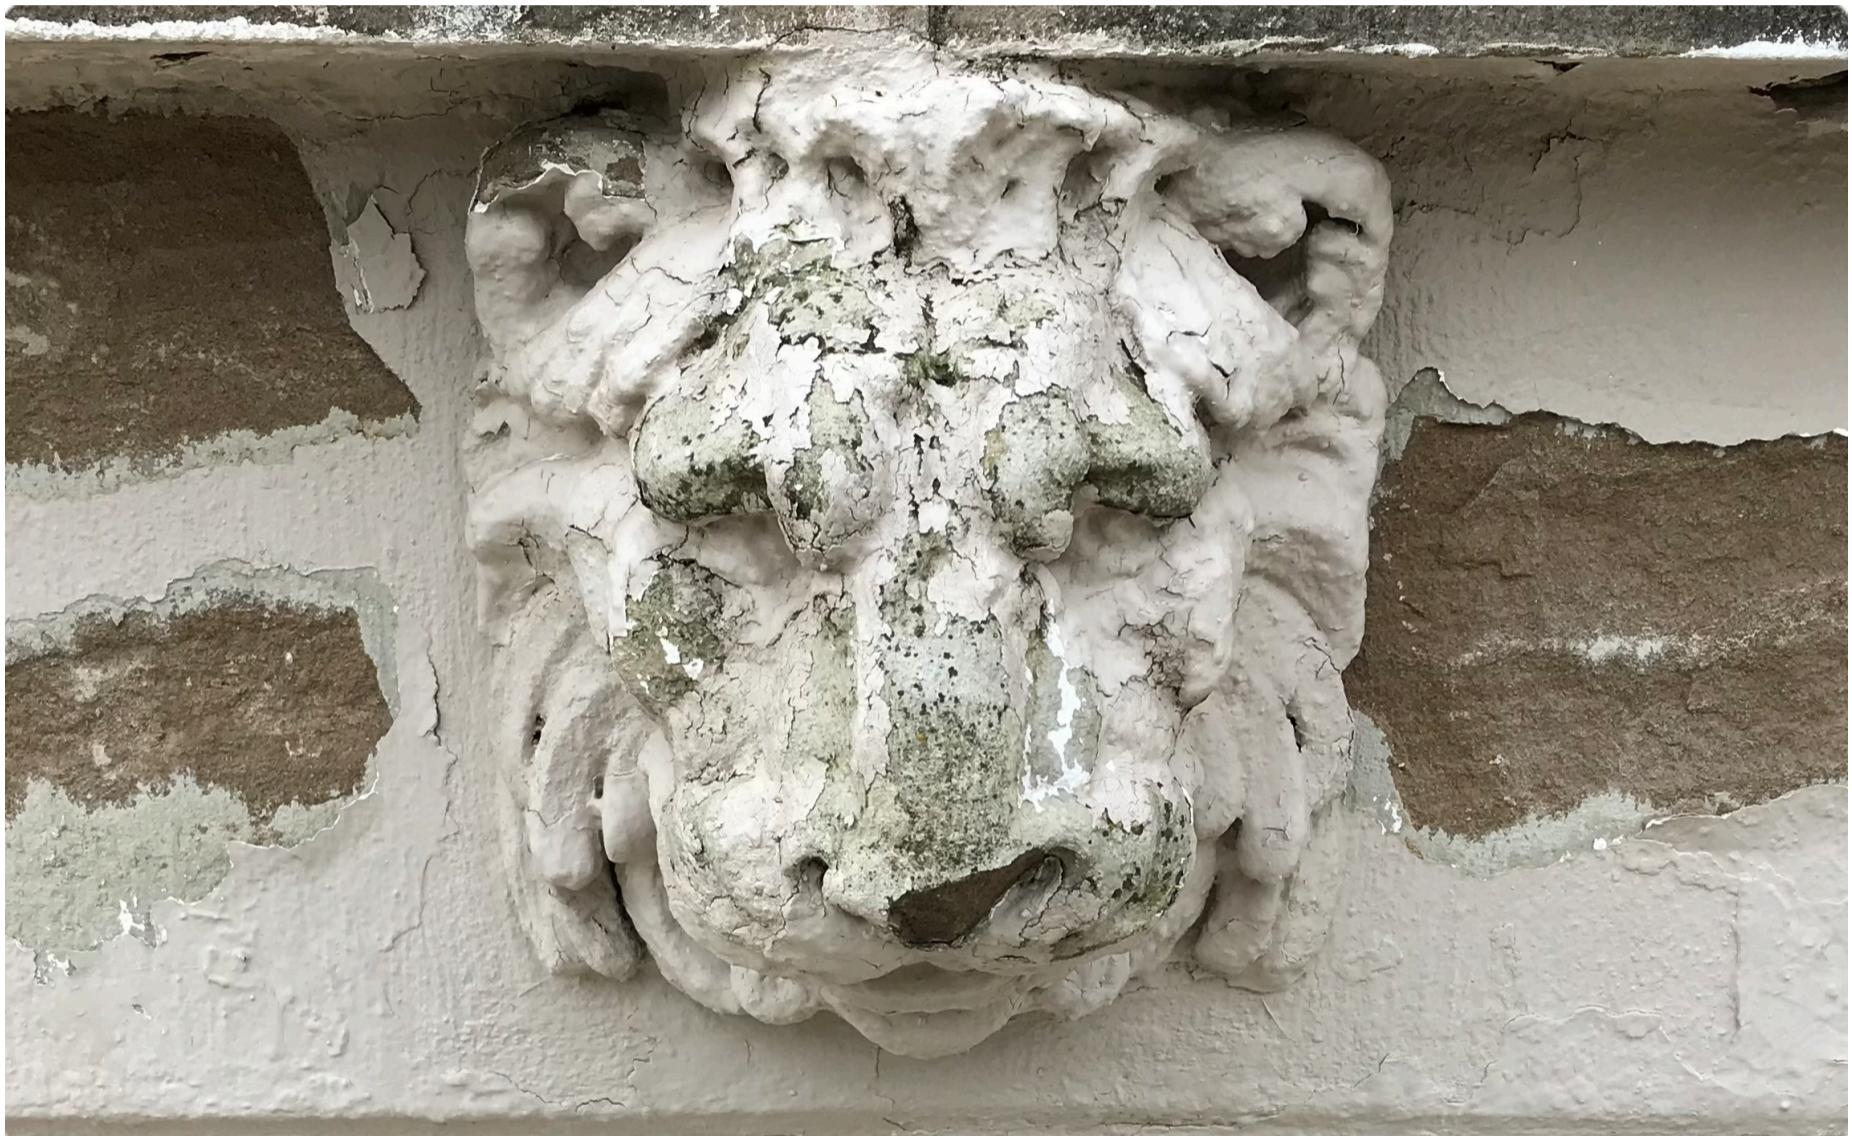
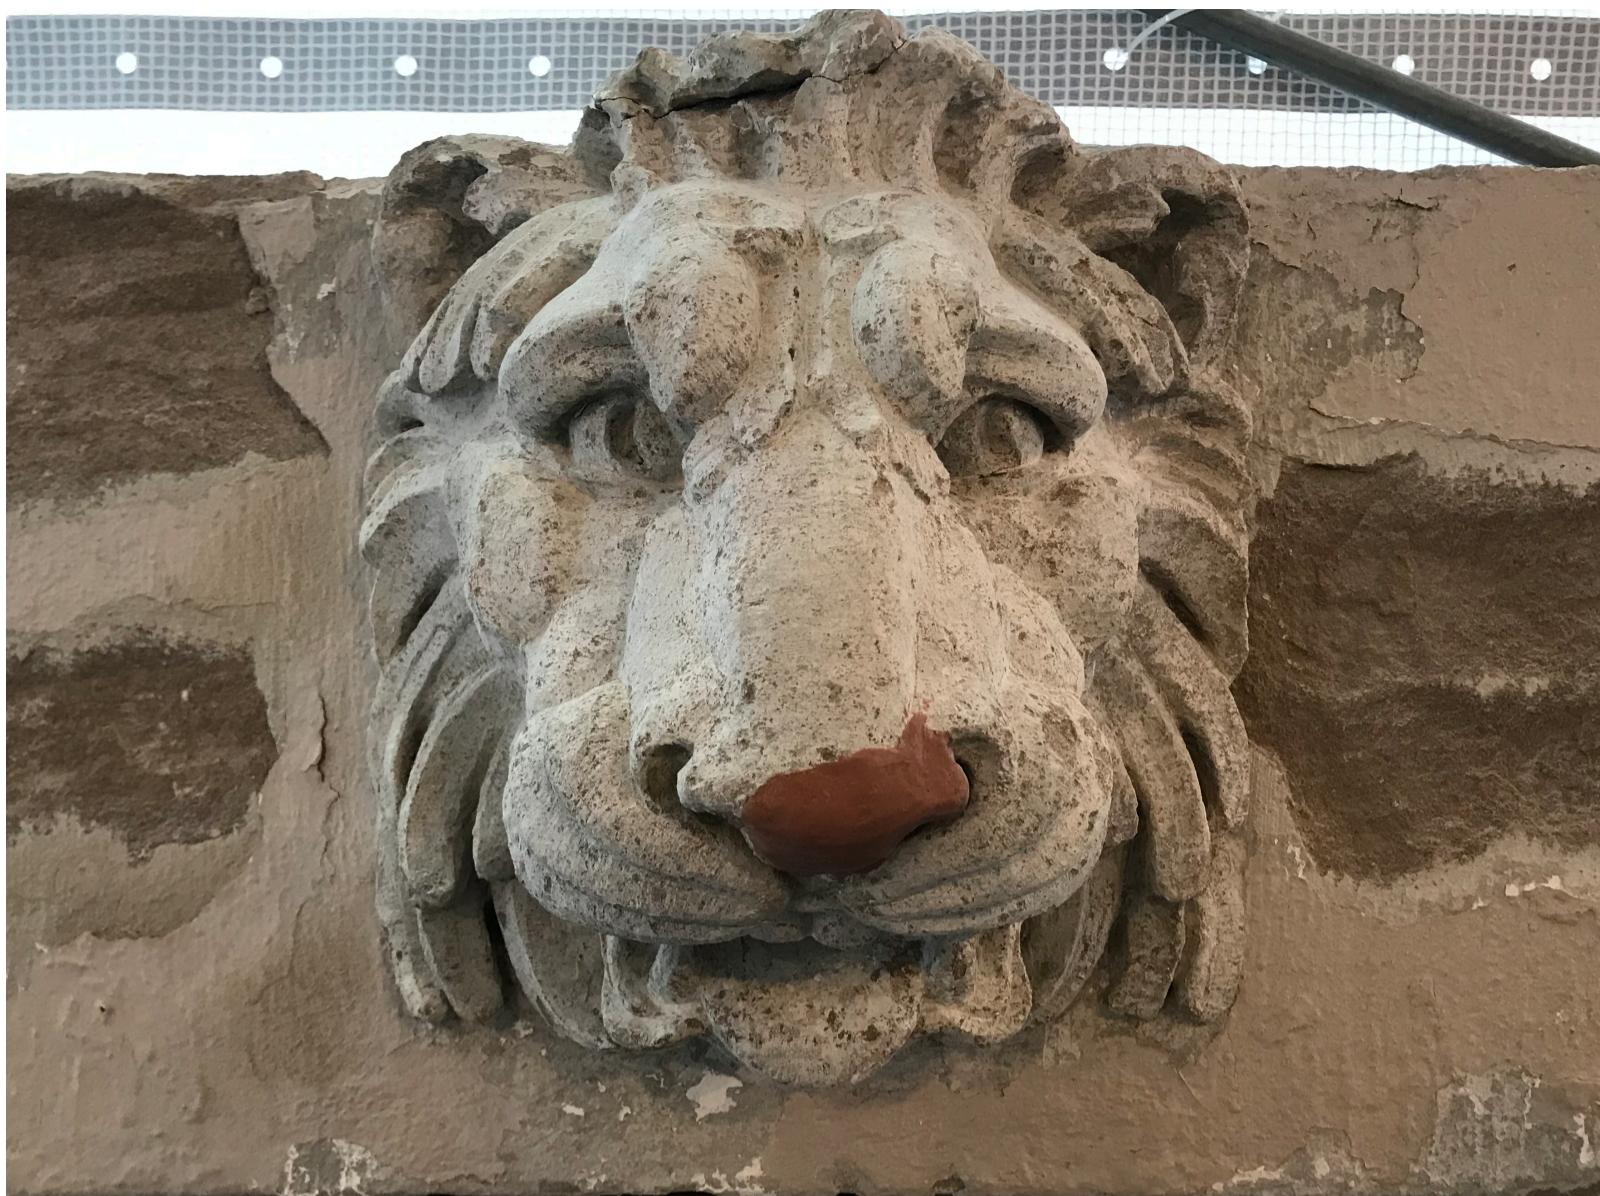
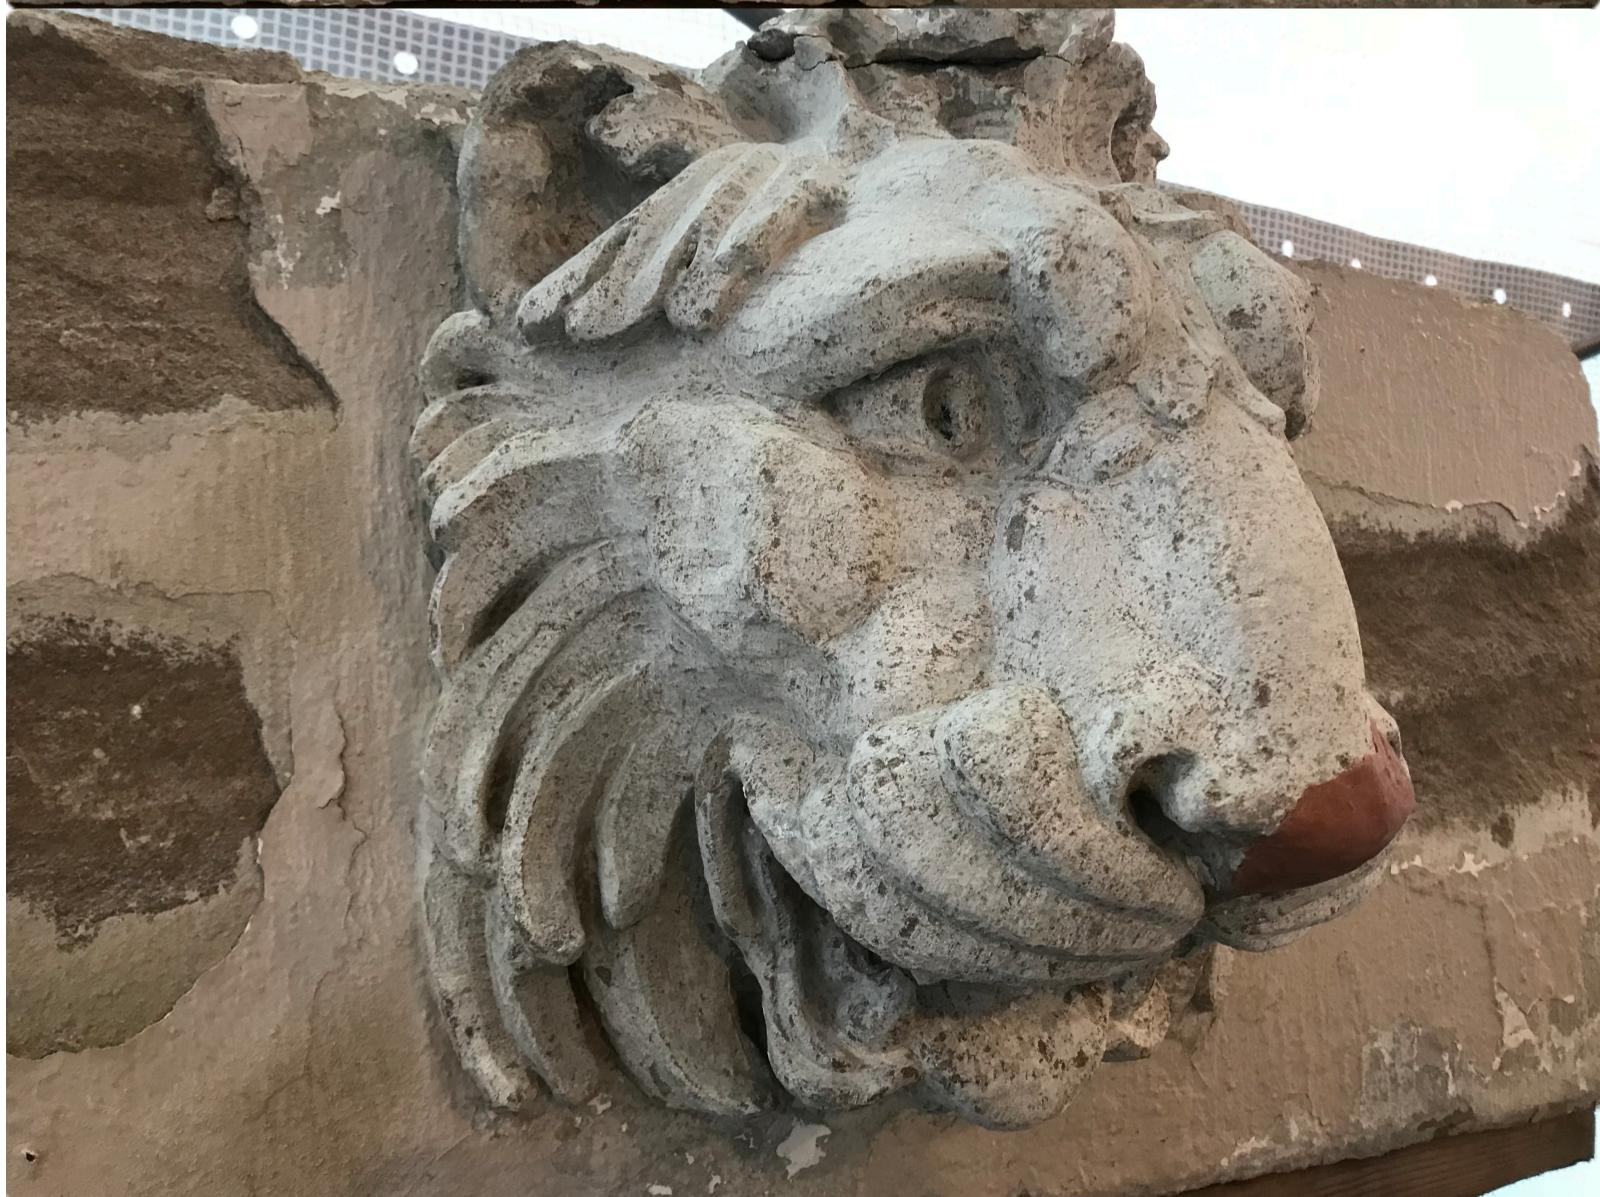
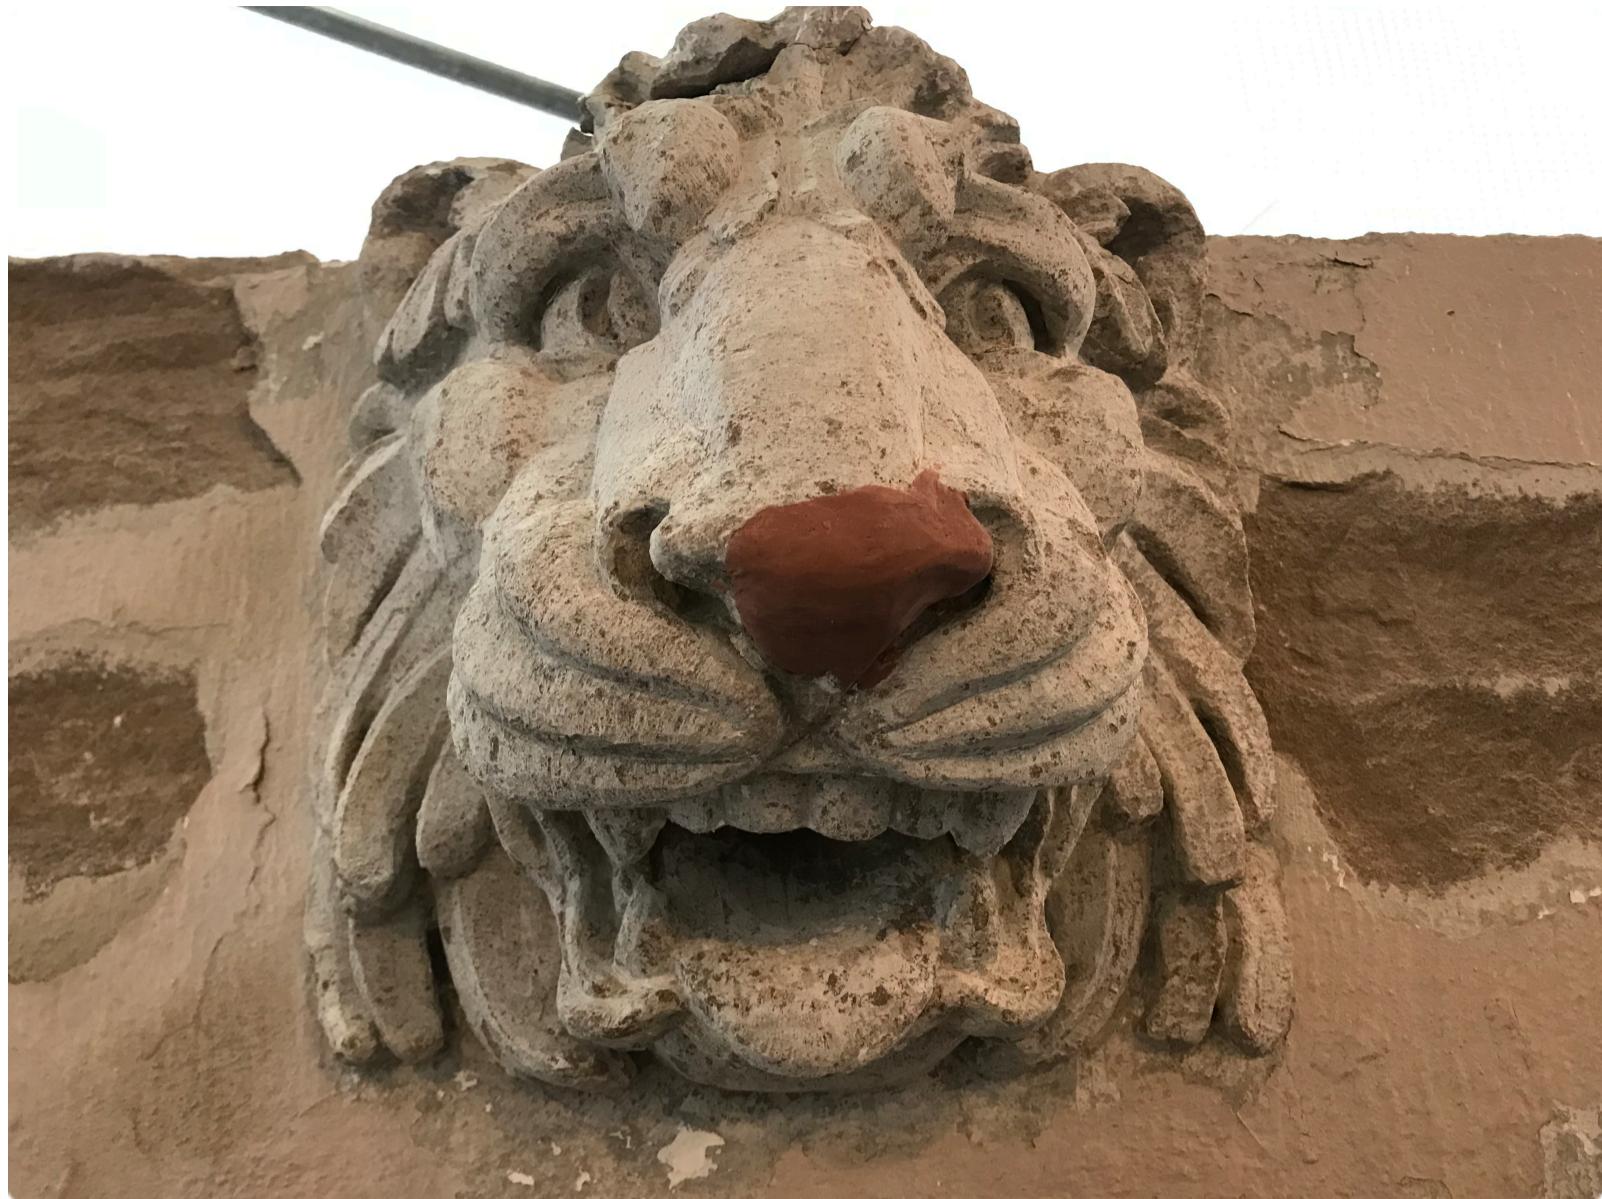
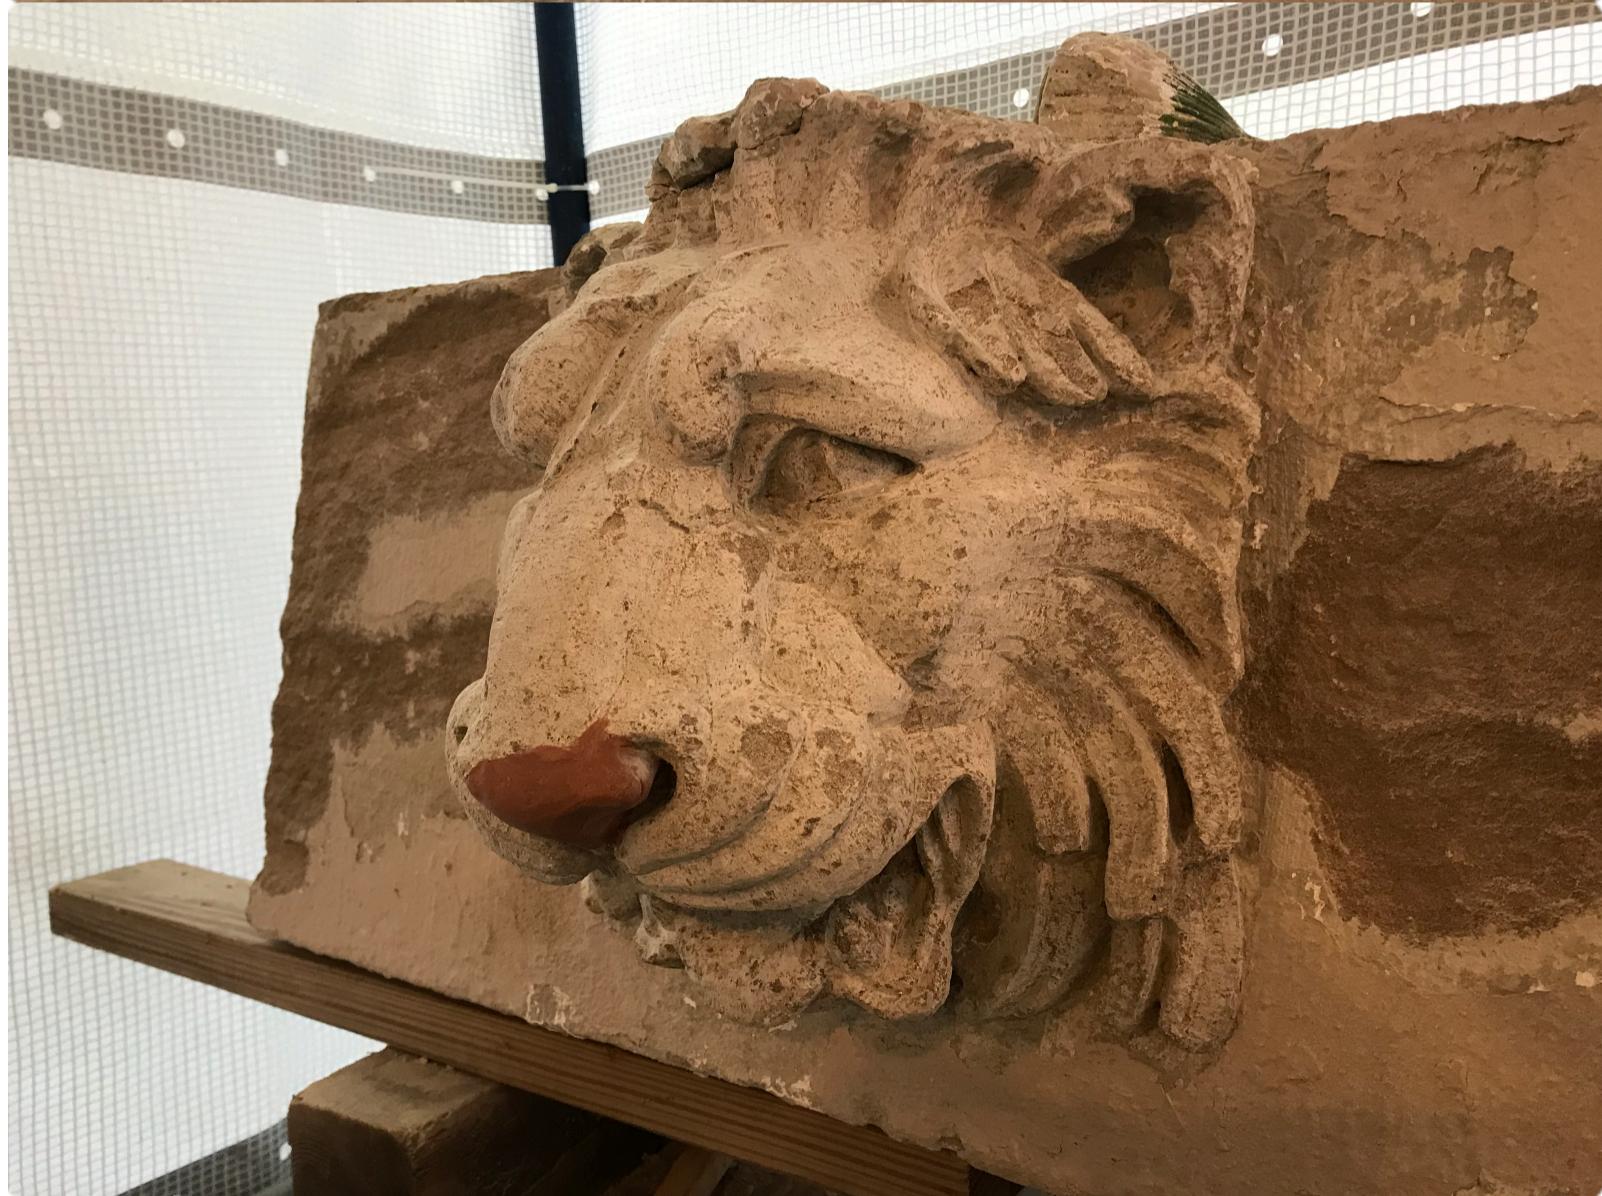
The Lion's Head is almost entirely intact. A small section of the nose has been lost. The carving was coated with a thick sealant that hides fine carving details. The sealant appeared to be cementitious. It was mechanically removed with fine chisels.

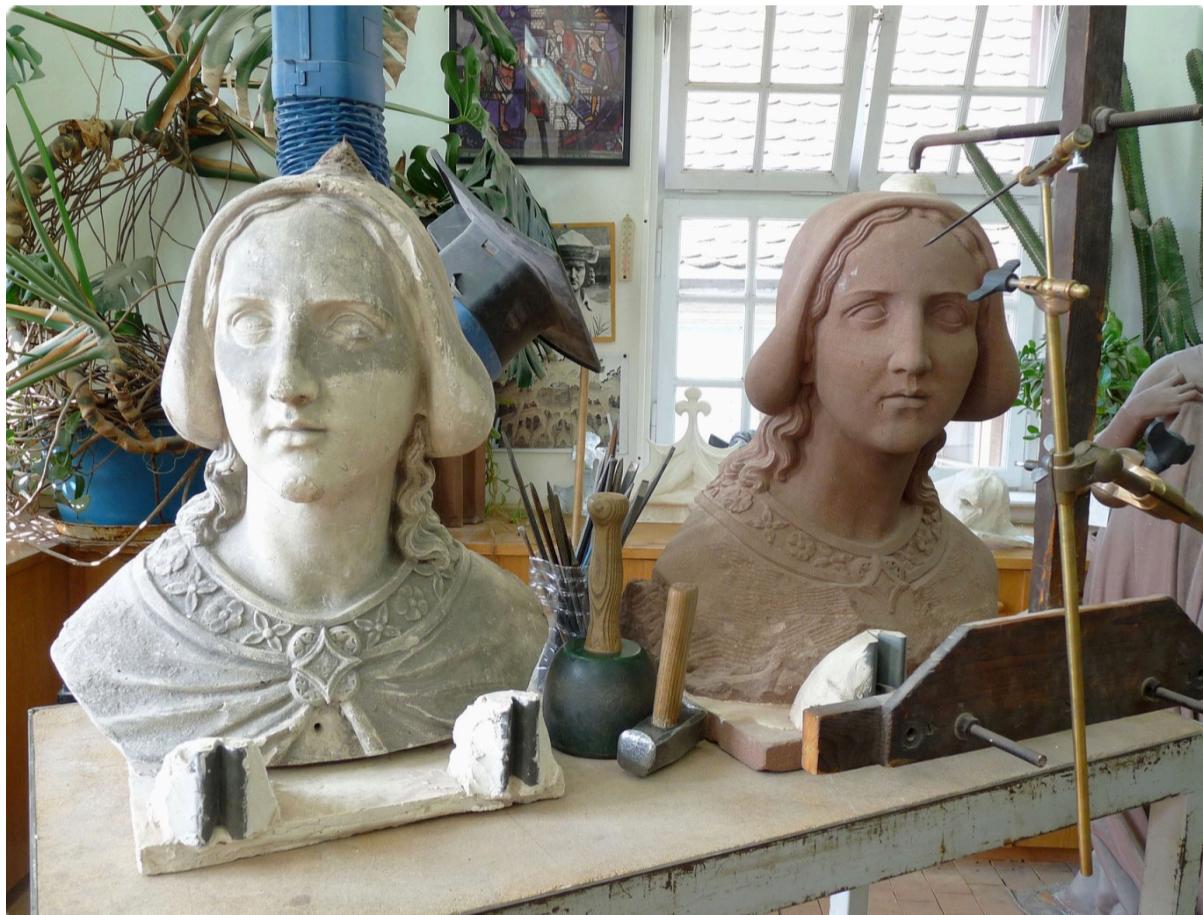
The lion's head will be recreated with the use of a manual pointing "machine" which will transfer dozens of three dimensional points from the original carving to the new stone. The remaining carving will be shaped with visual reference to the original.

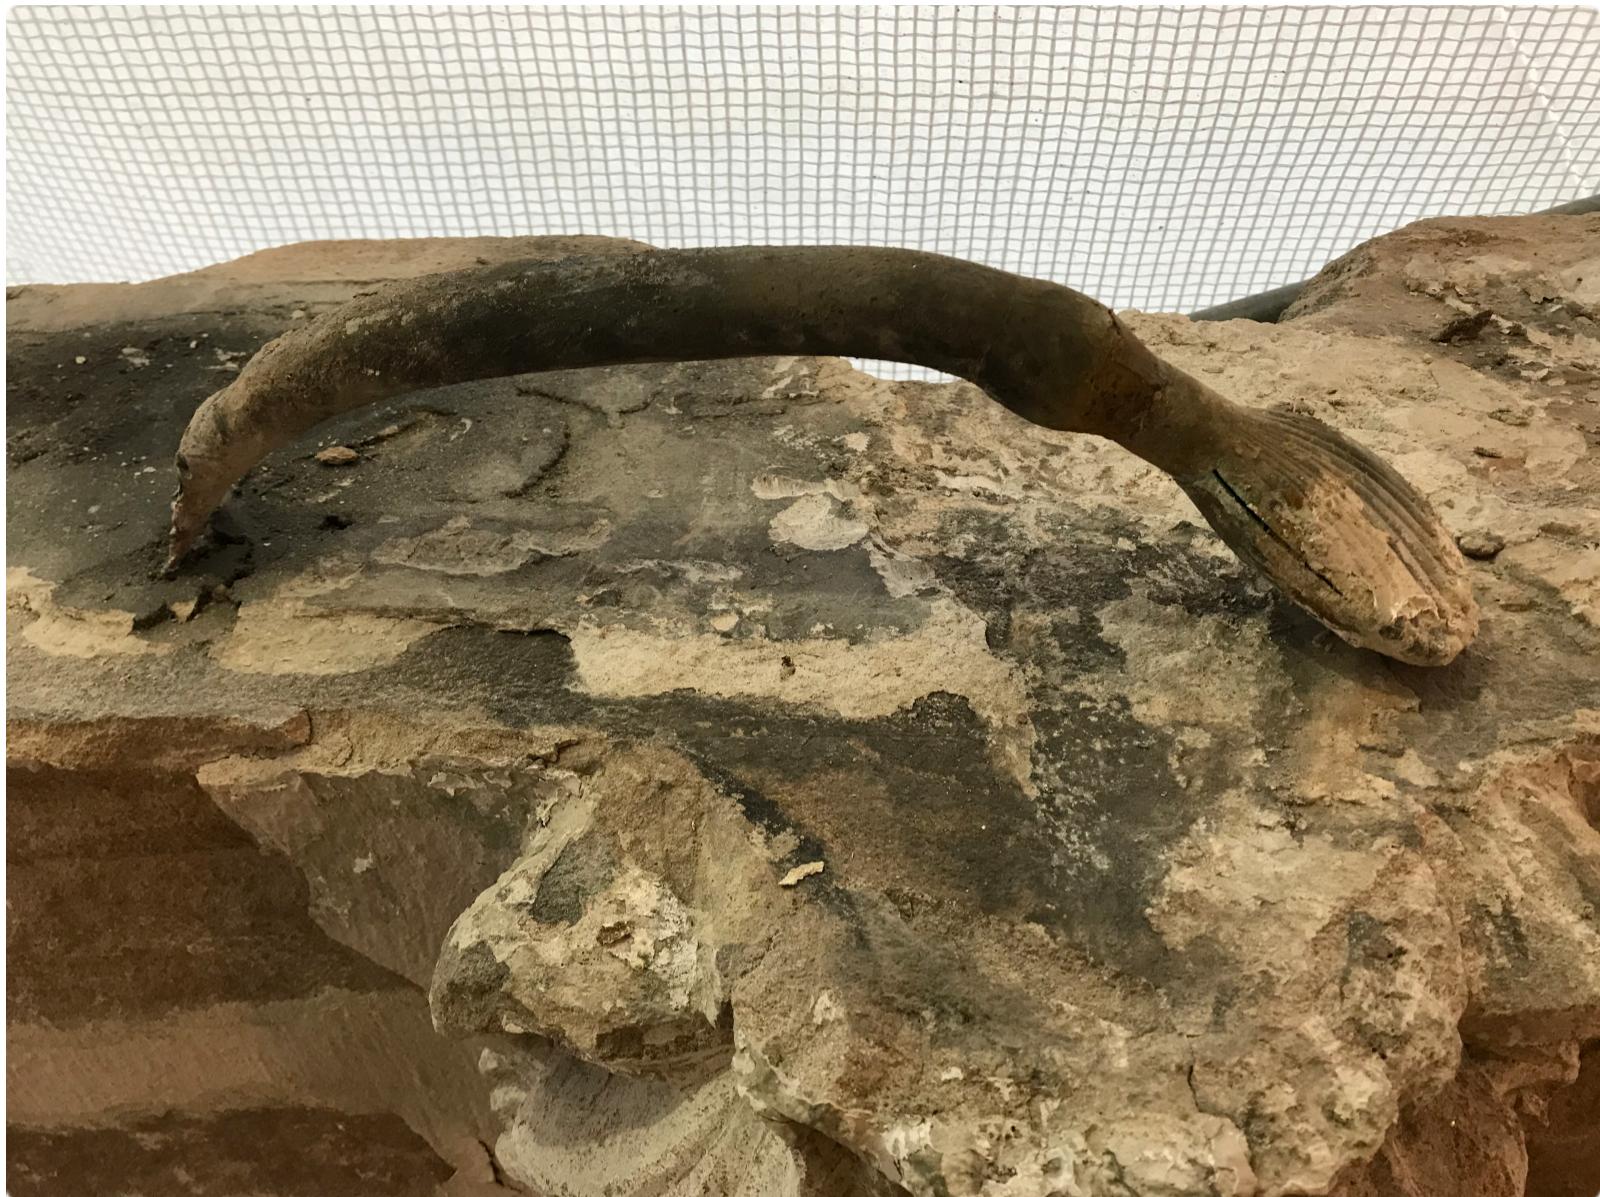
*The original water supply pipe with a fan-shaped spout.*

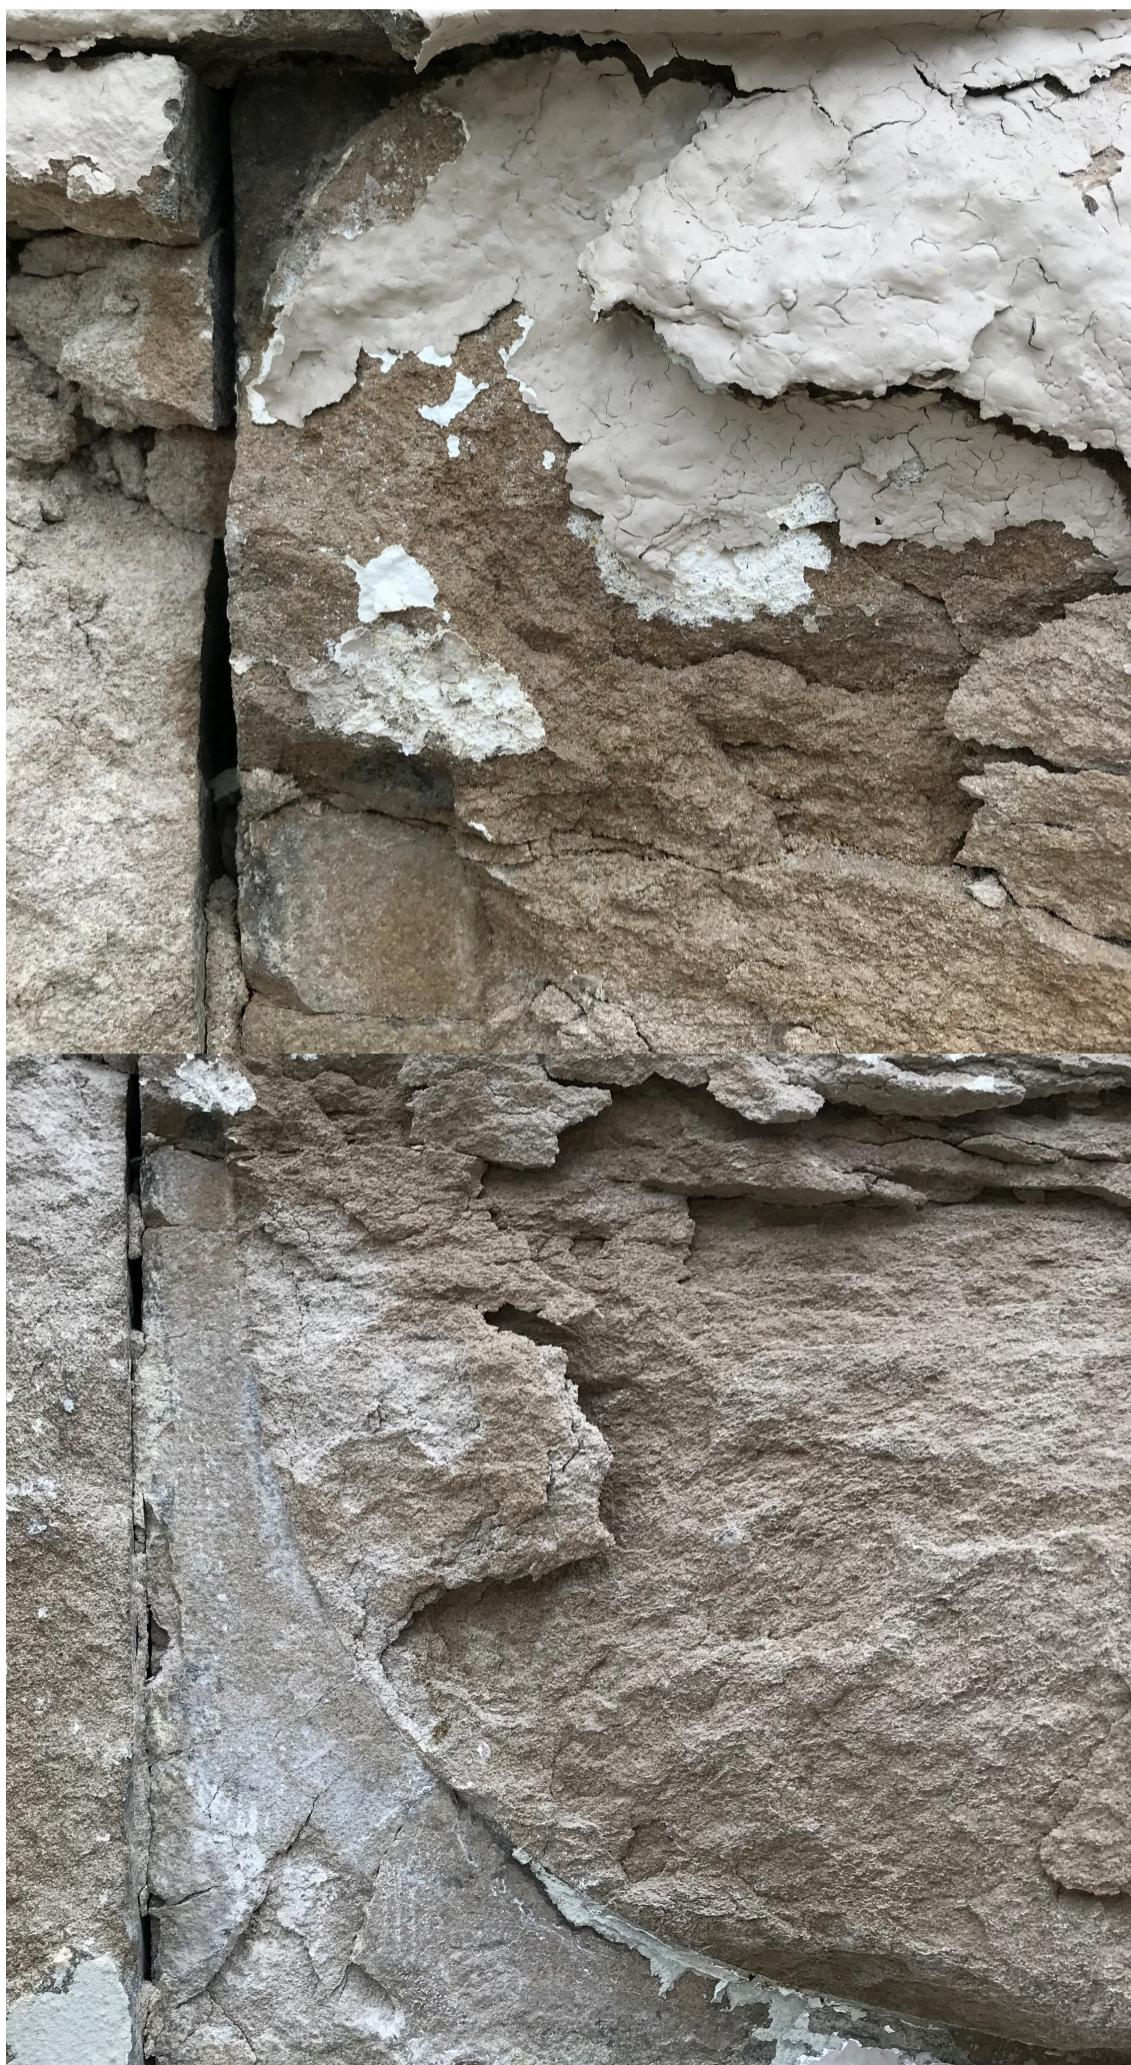
The bowl had been fractured by blunt force many years prior. Only a few inches from the wall face remains. What remains shows the exterior profile of the bowl, including the rim moulding.

*The rim moulding is an ovolо measuring 3 3/4" H, 1 1/2" W.*

*The drip edge appears flat and measures 1" deep*

*Below the rim moulding the exterior bowl appears circular with approximately a 10" radius. Tangents extend the circle to 16" from the left and right arris.*

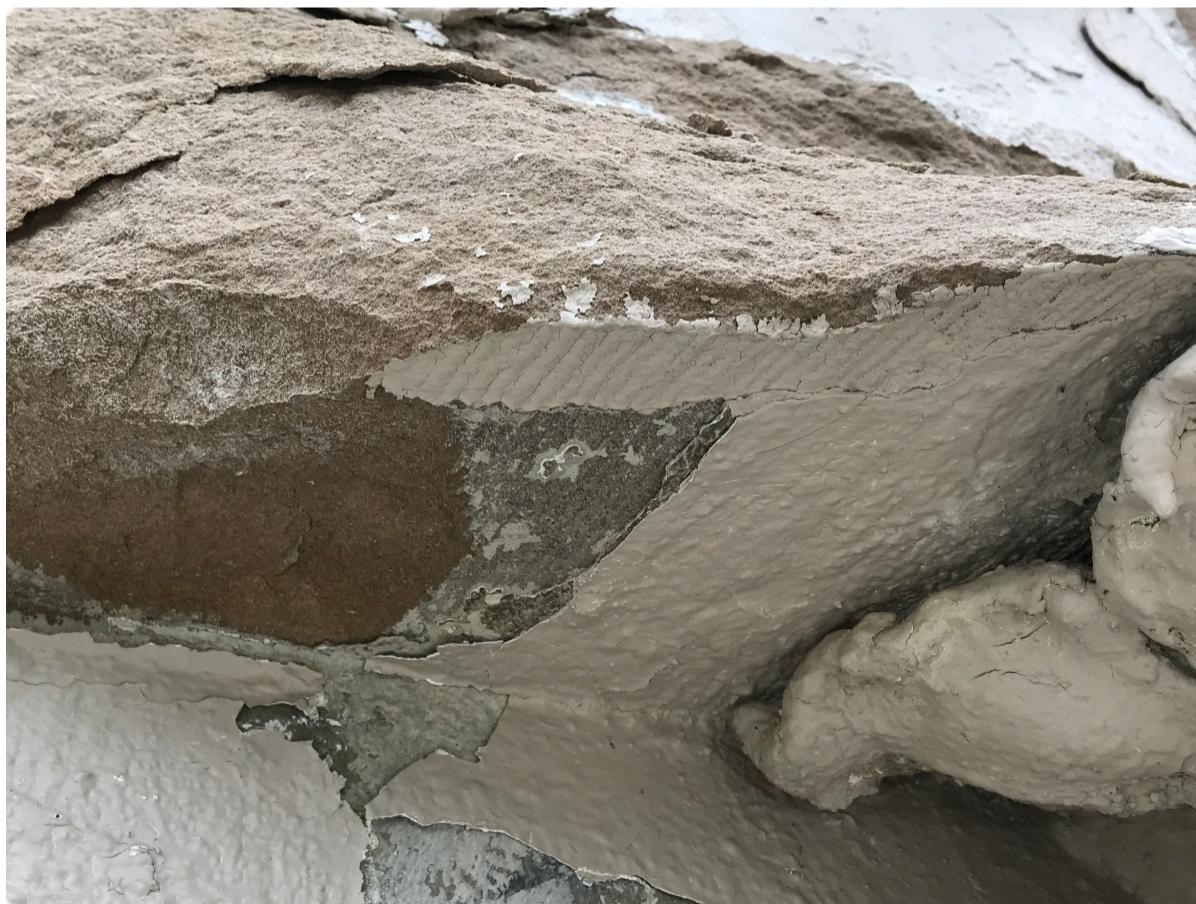
*The flat underside of the bowl will be batted along the depth of the stone 4-5 batts/in (\*6 batts/inch). The rounded exterior surface will be sanded.*

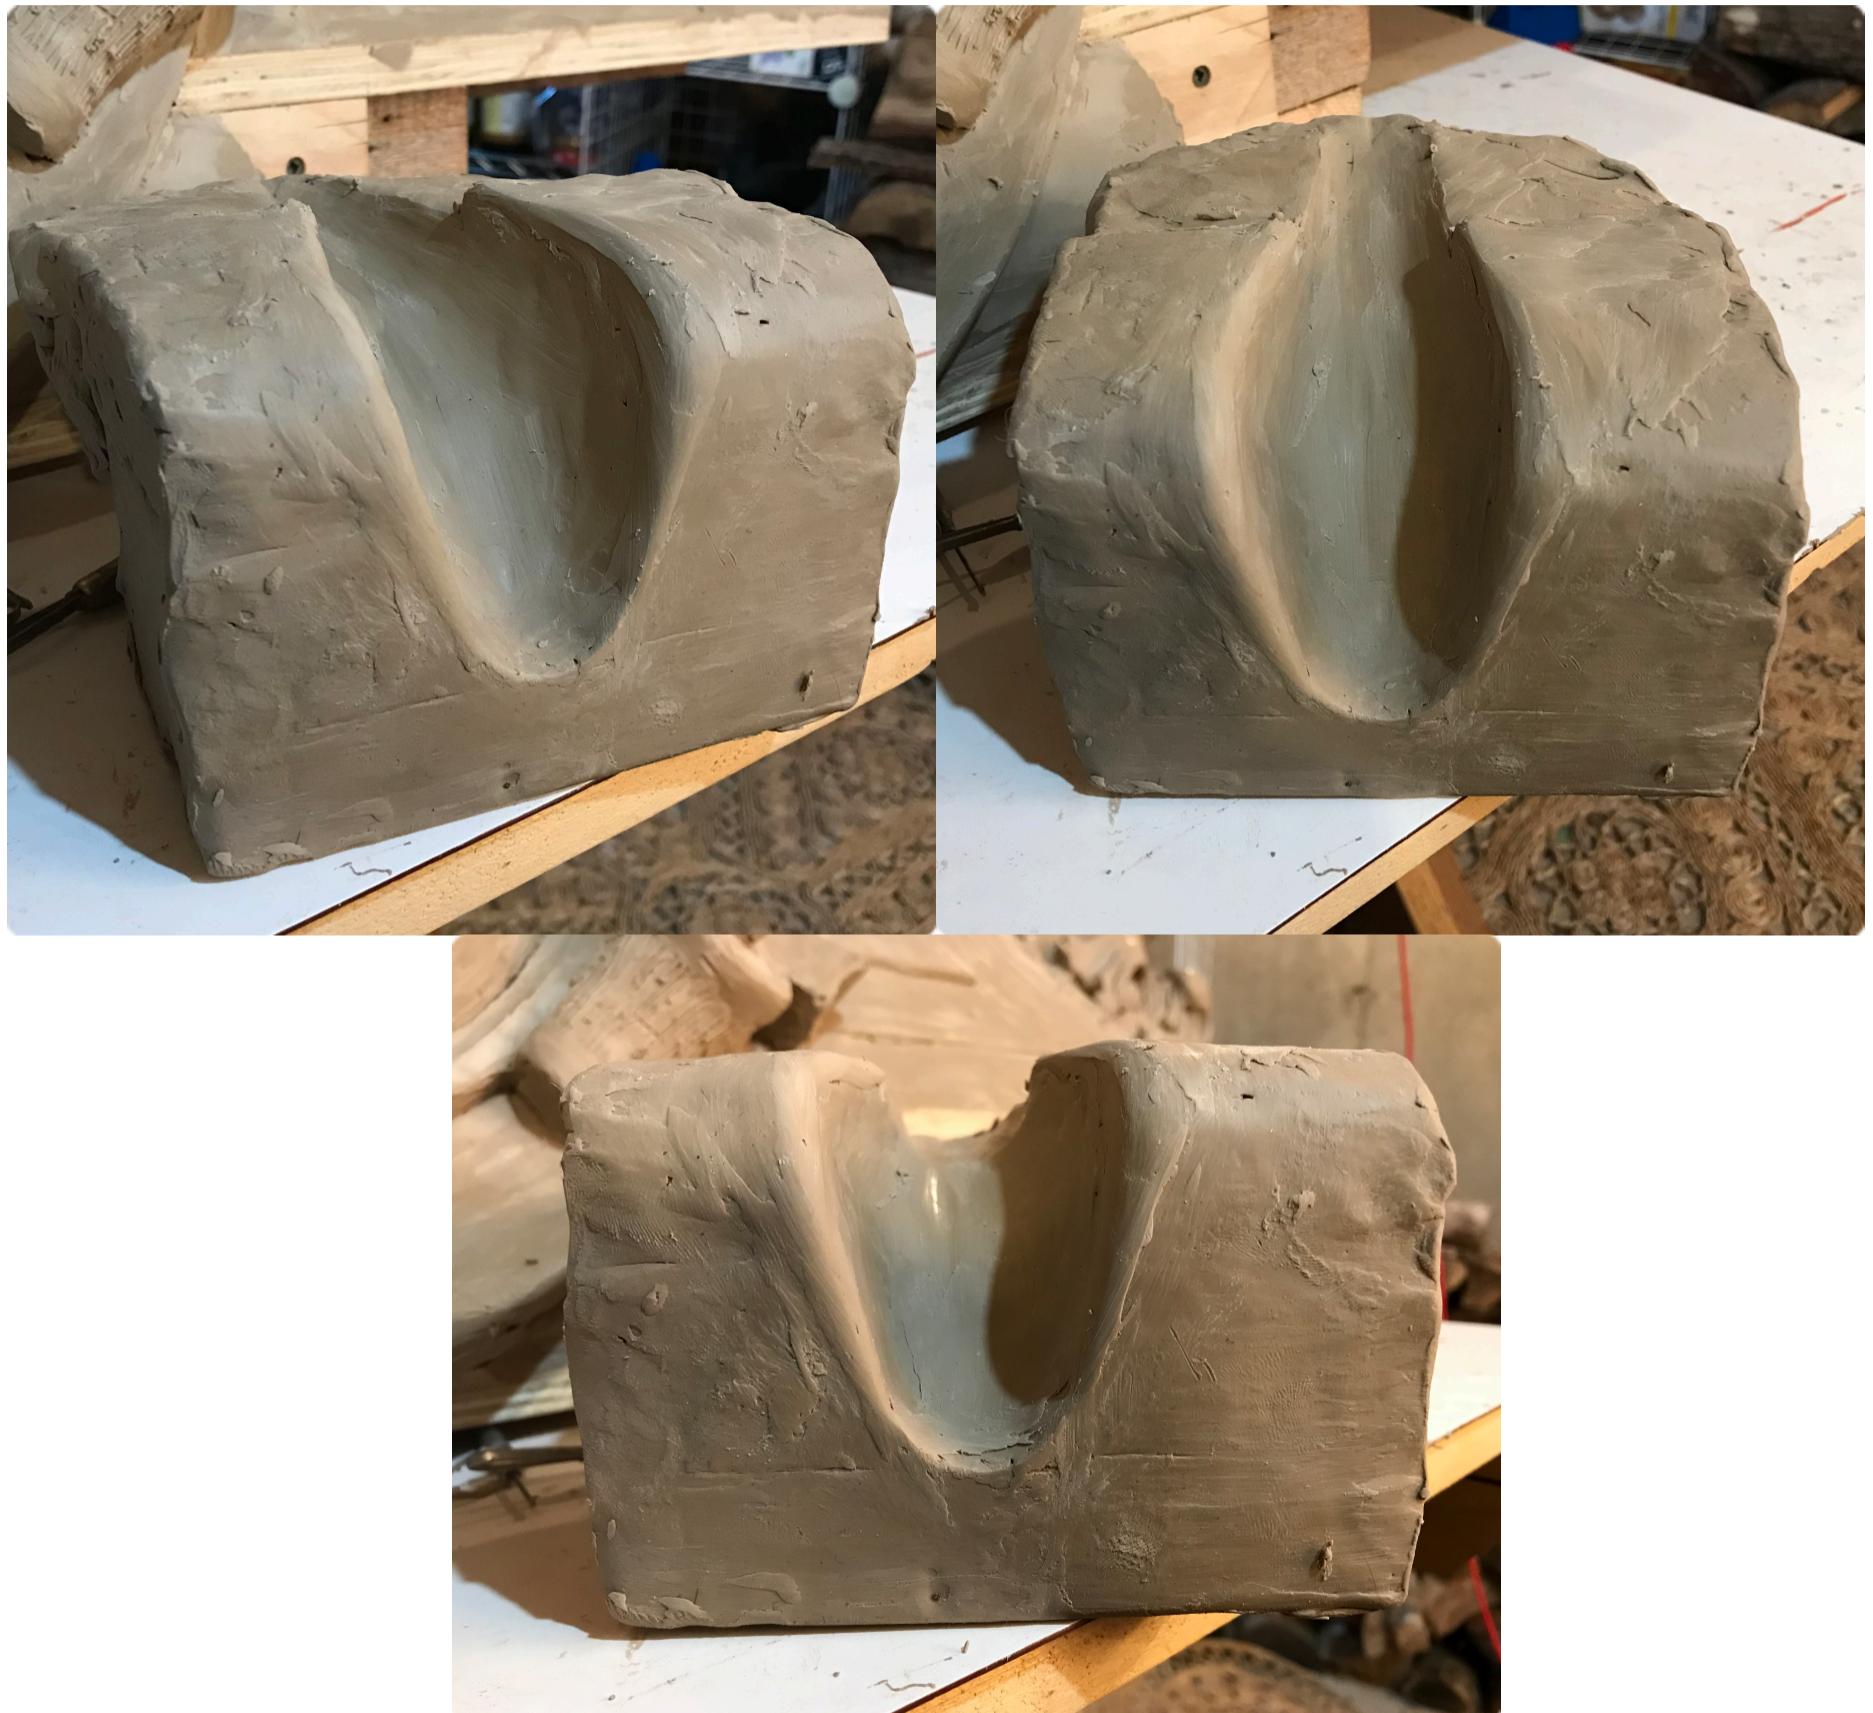
*Clay maquette showing modification to scupper design*
