Hennessy Hall

# Carved Elements - Design Proposal

**Prepared by Scott Harris, FUNDY STONECRAFT**

**Jan 2, 2023**

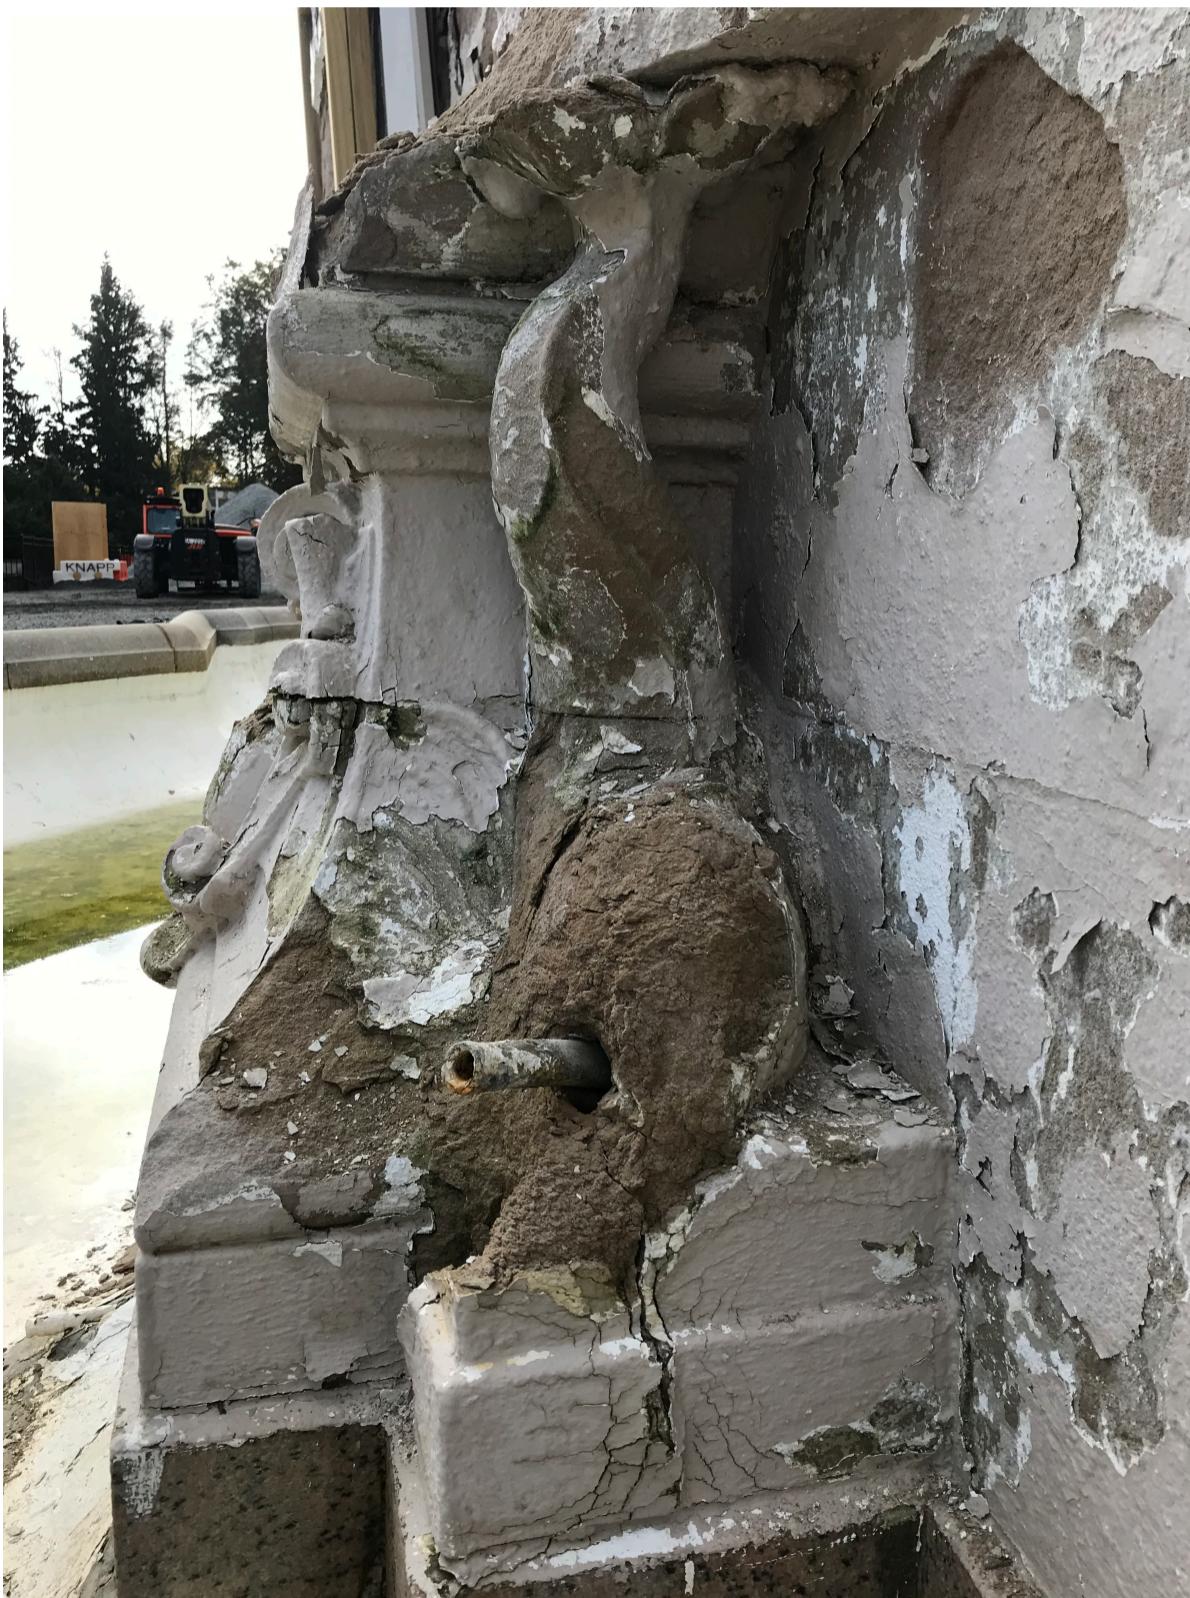
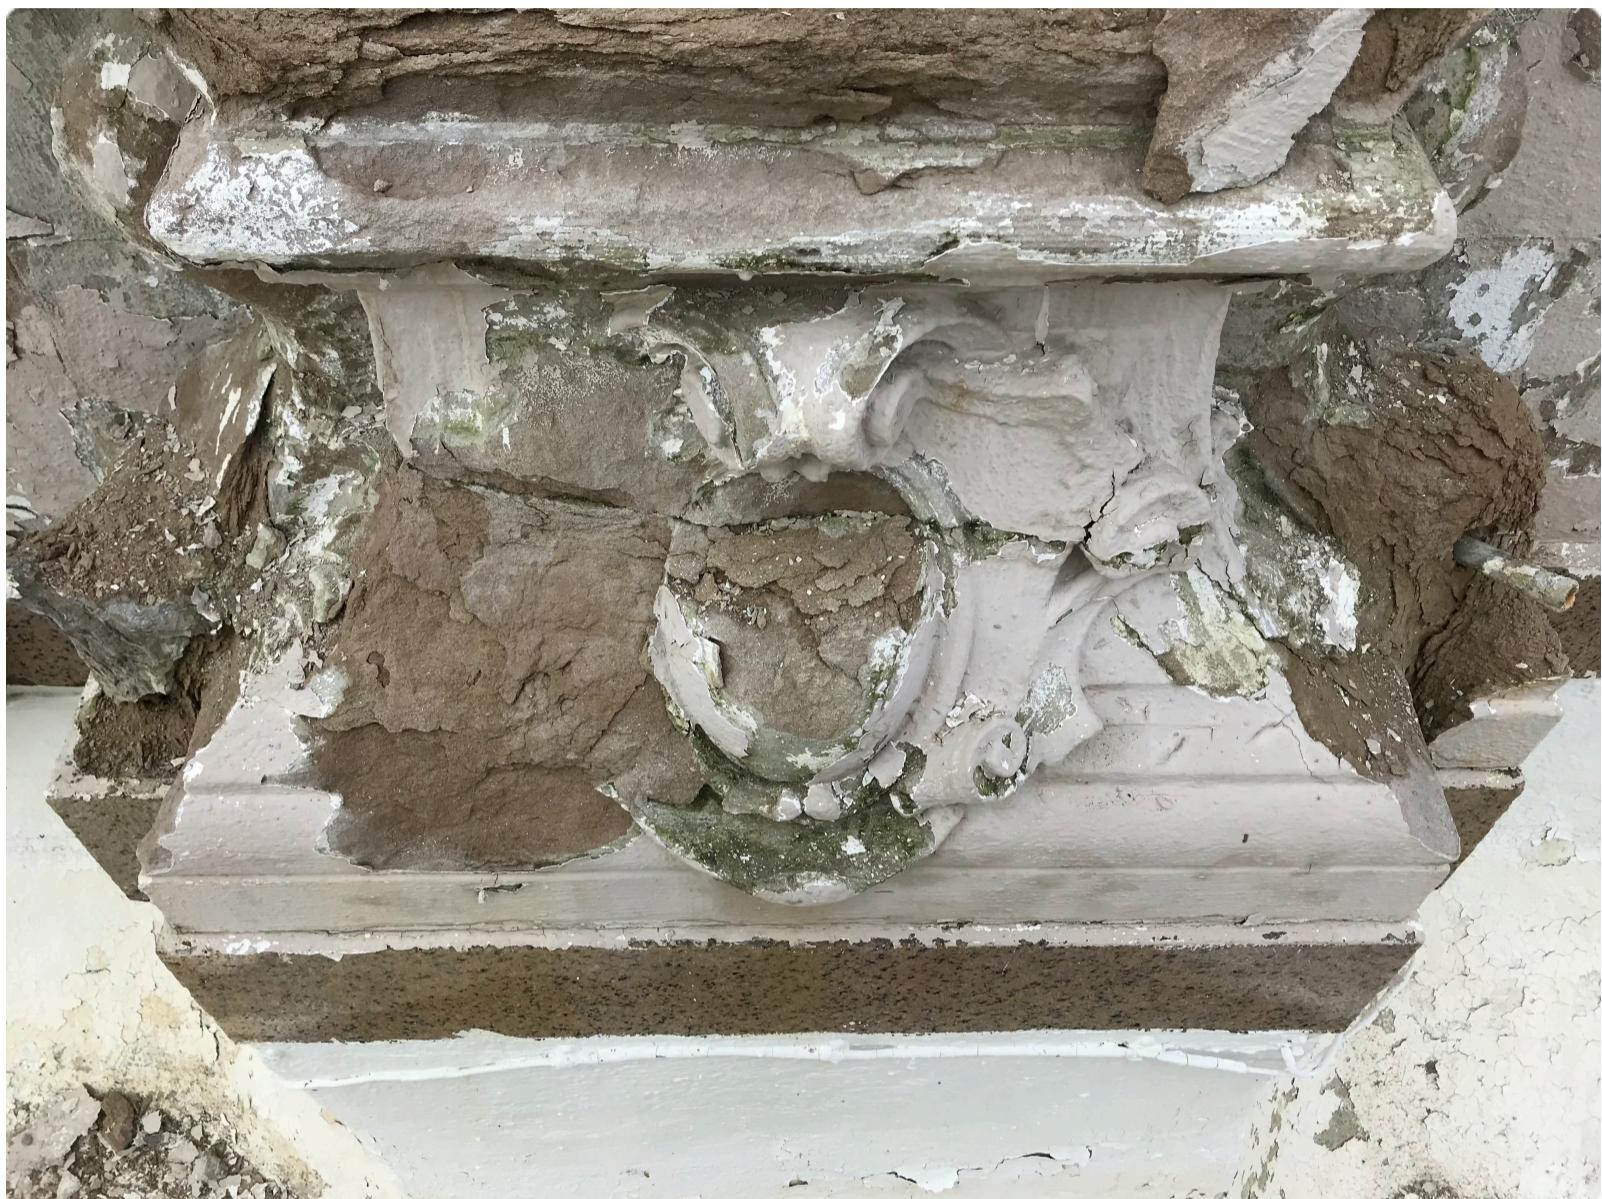
Although severely worn, the pedestal still provided all moulding dimensions and all the required dimensions of the cartouche. The existing condition of the dolphins provided information on the body, tail fin, and some outline of the pectoral fin.

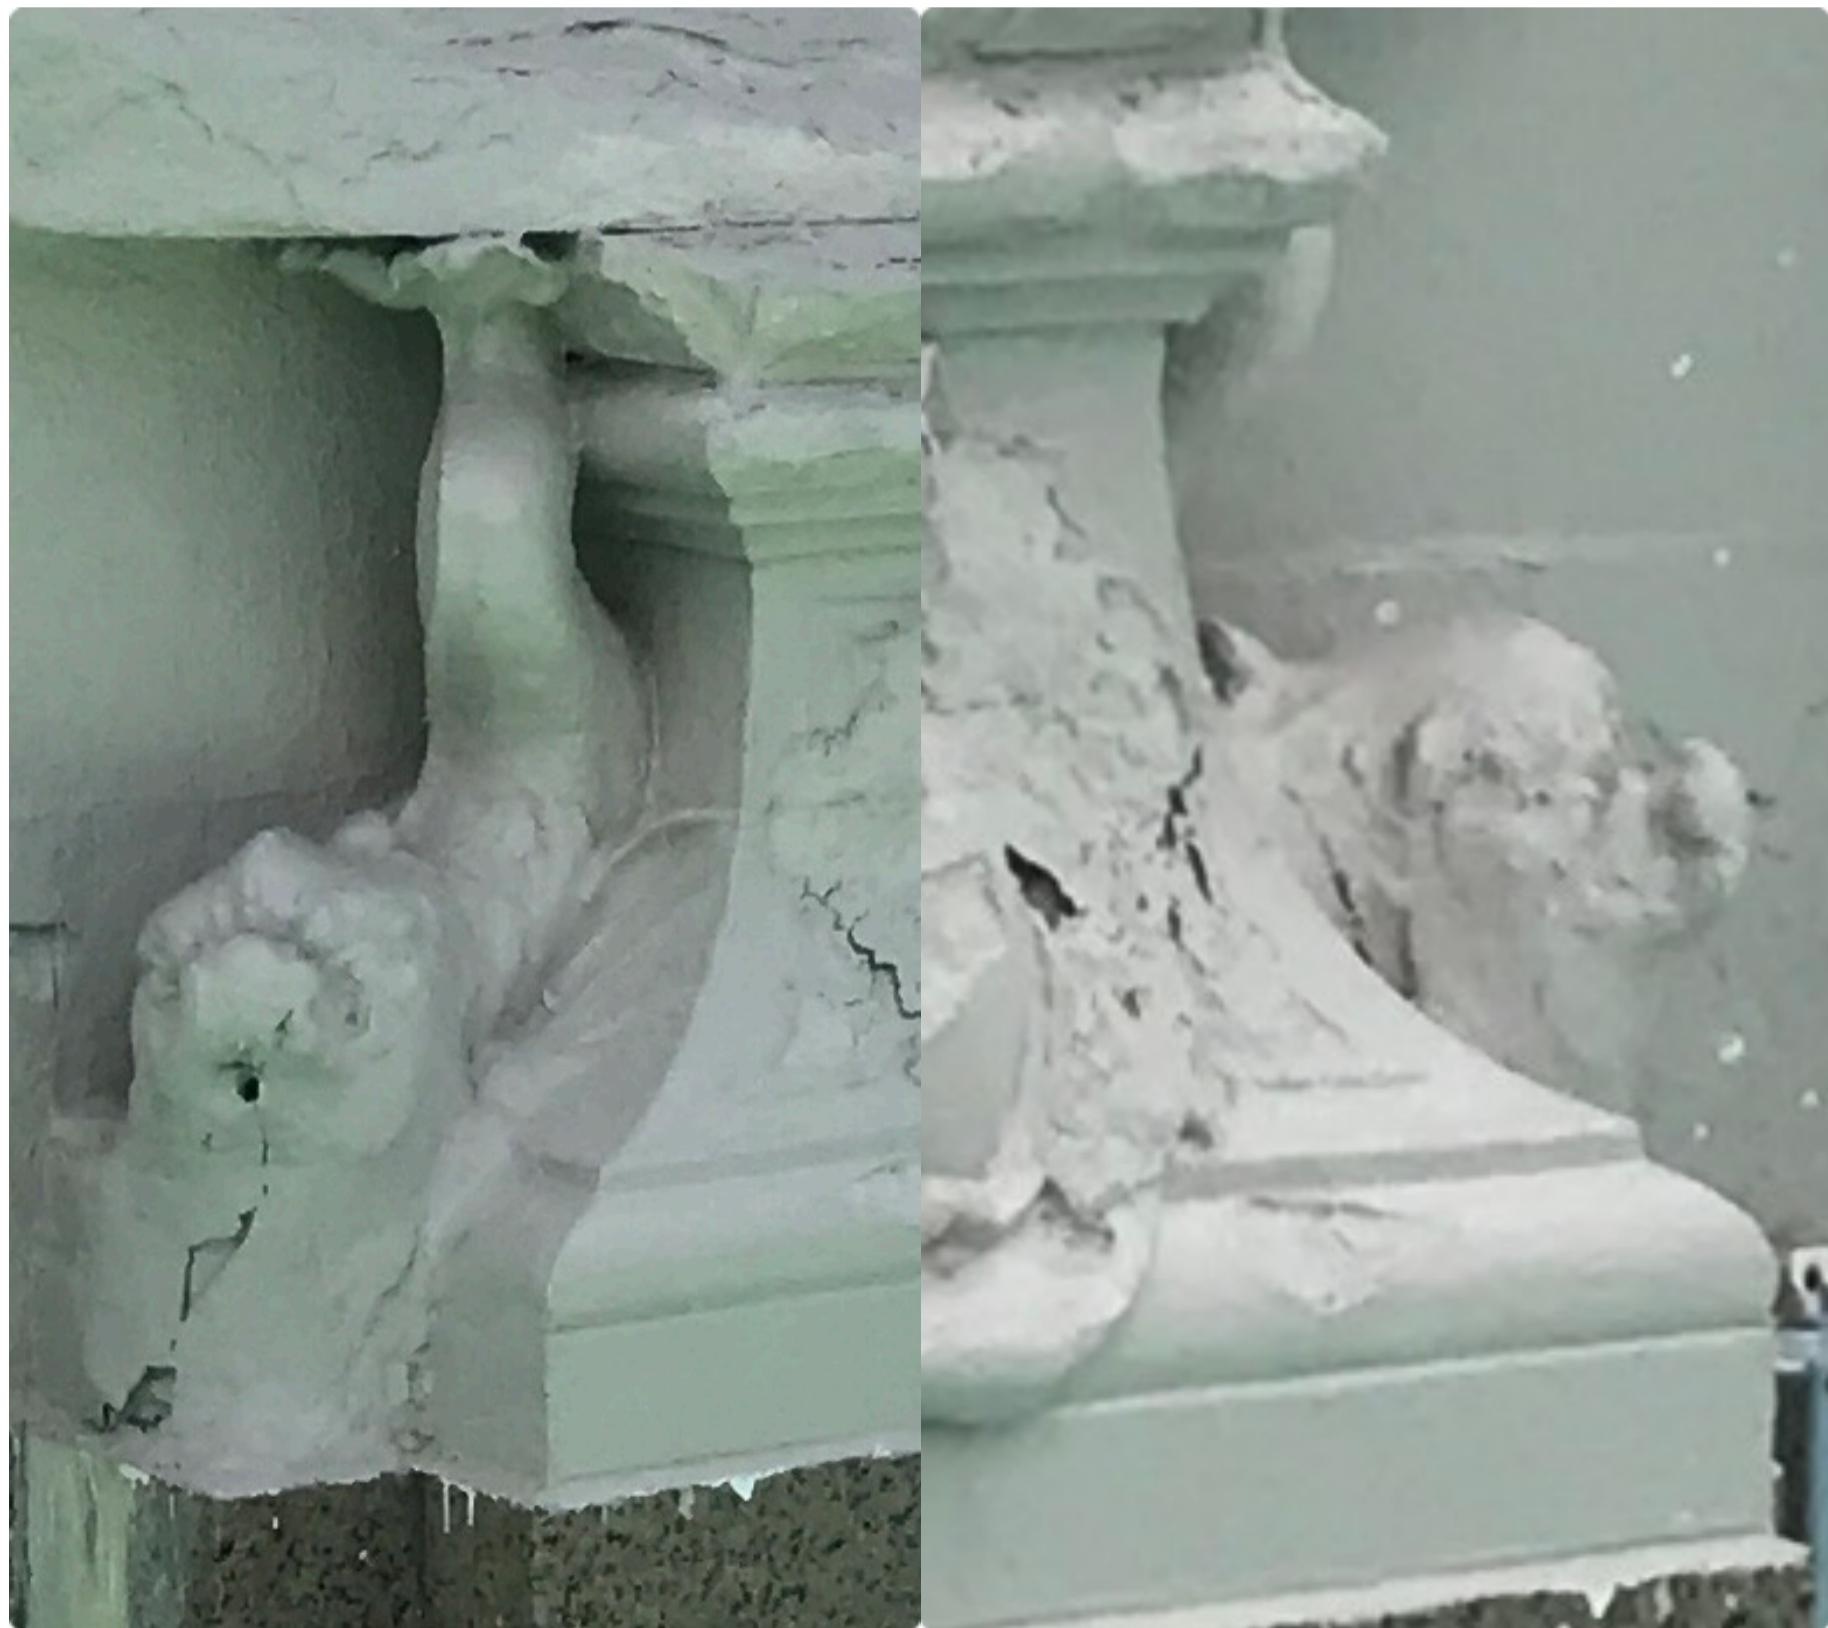
Photos provide a front and side elevation of the dolphin's head, albeit deteriorated and coated. These photos show the style of "dolphin" that was originally carved, which wildly strays from the architects design - more of a dog-like fish than an anatomically correct dolphin. It is the original carving that I am attempting to replicate, not the architect's drawing, and to limit original design to elements that are completely missing. We can assume from these photographs that what originally existed had greater detail which had either deteriorated or been muted by the coating.

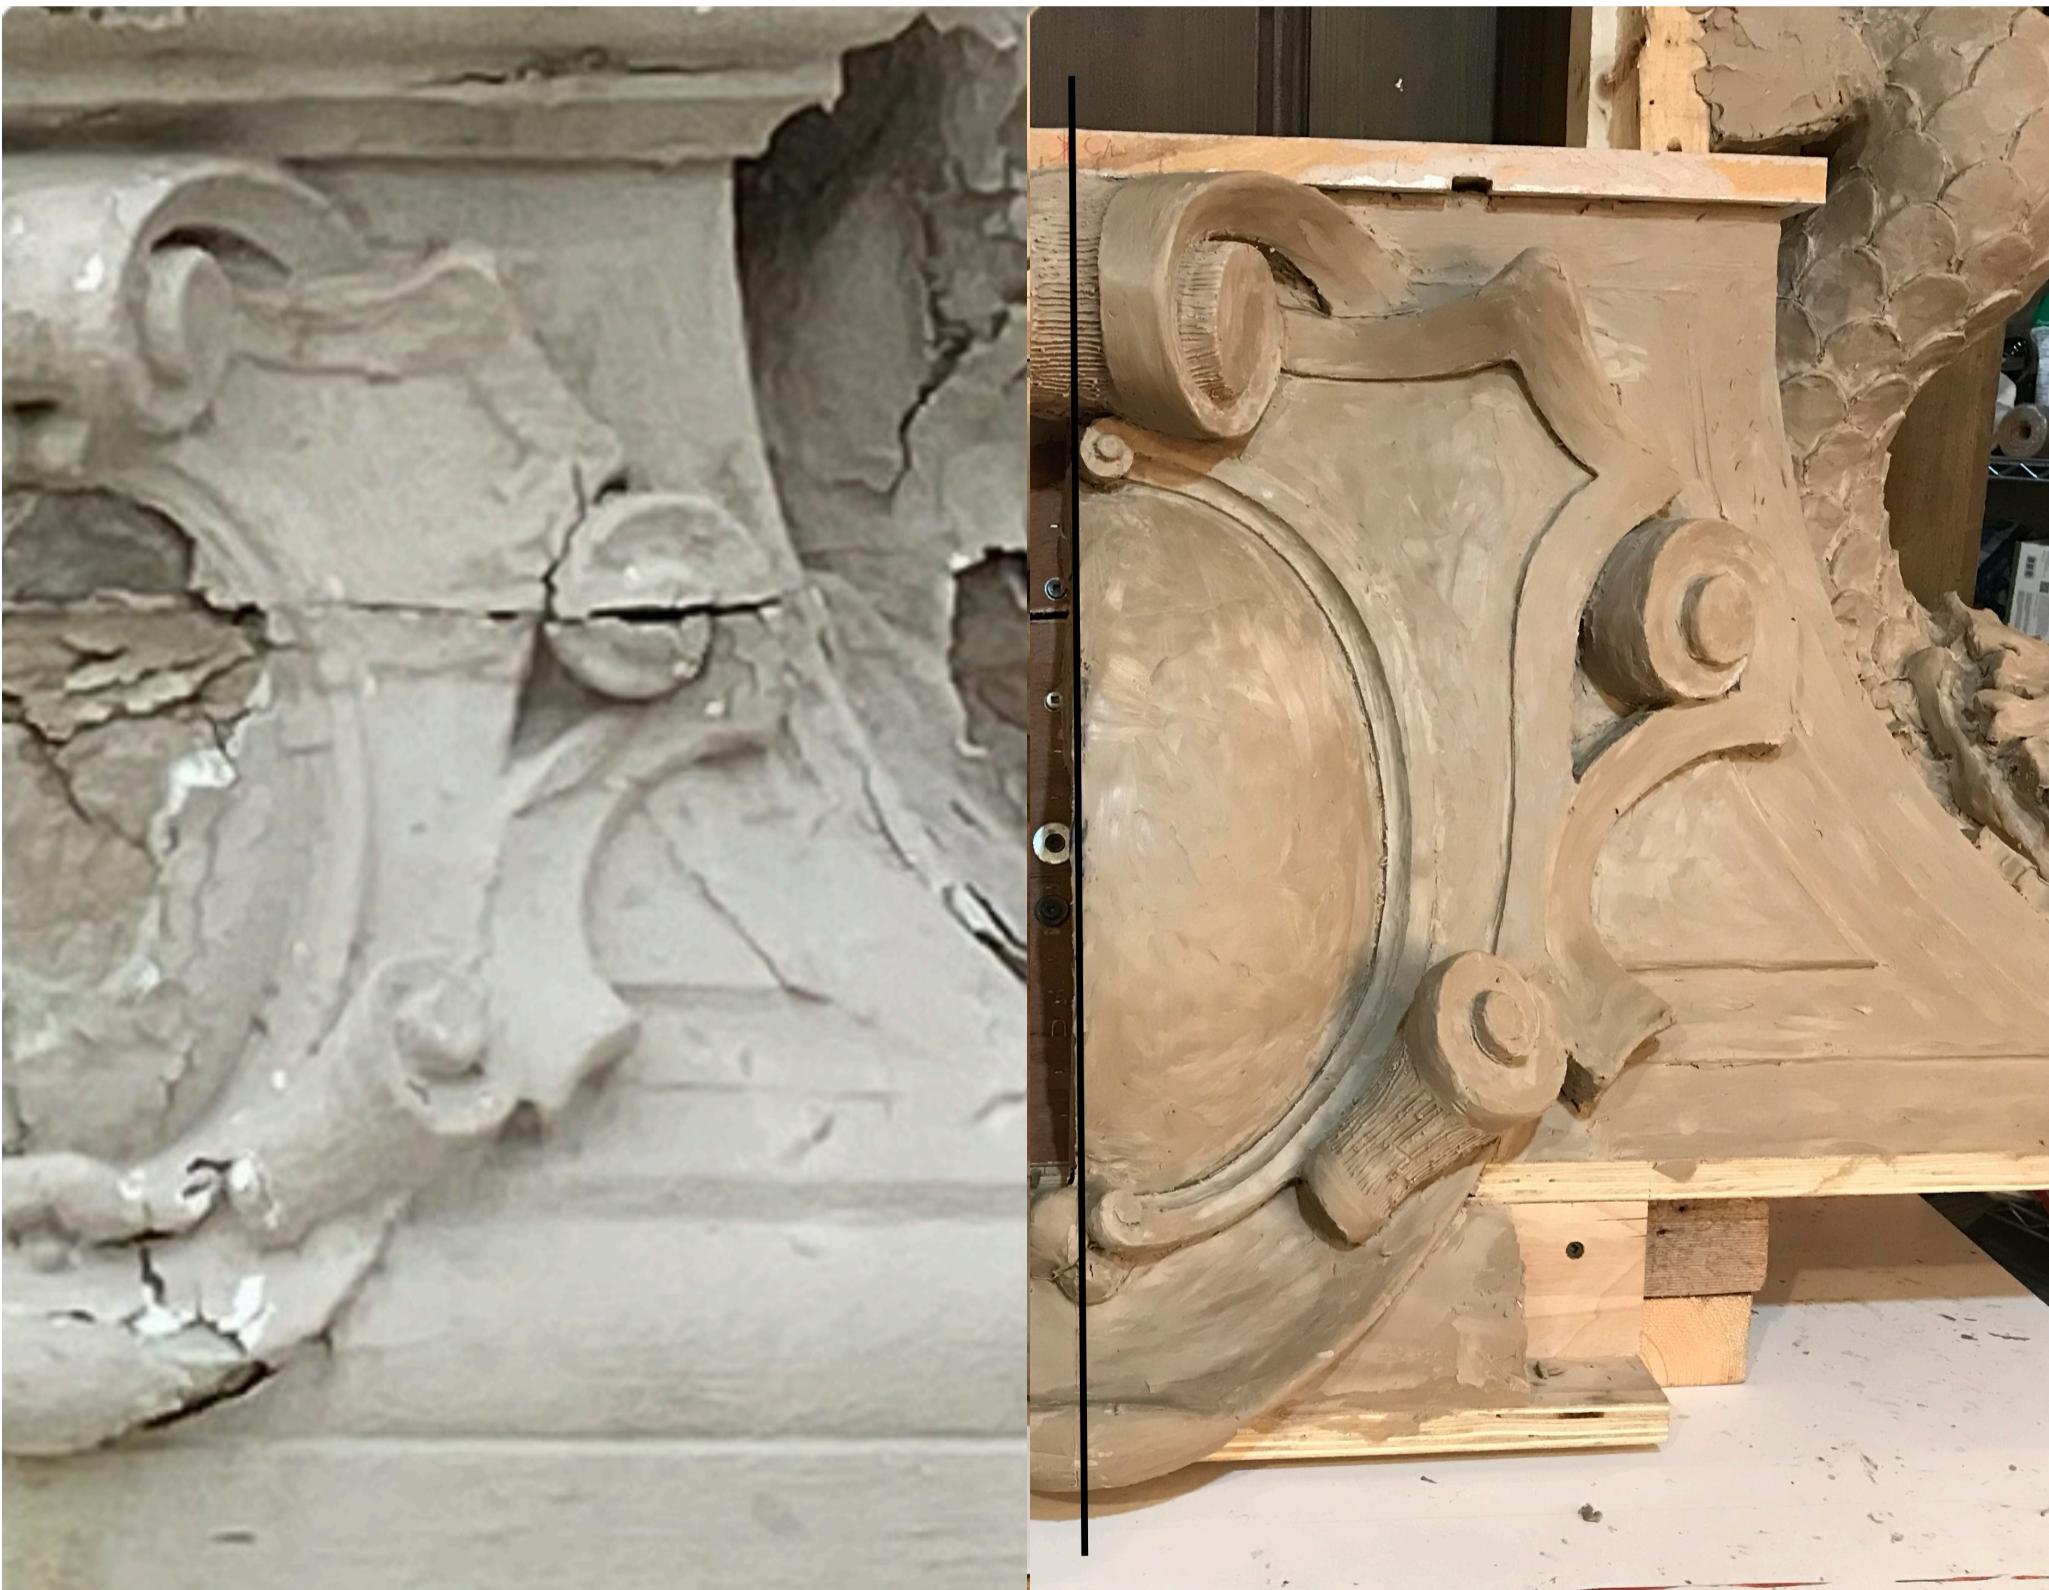
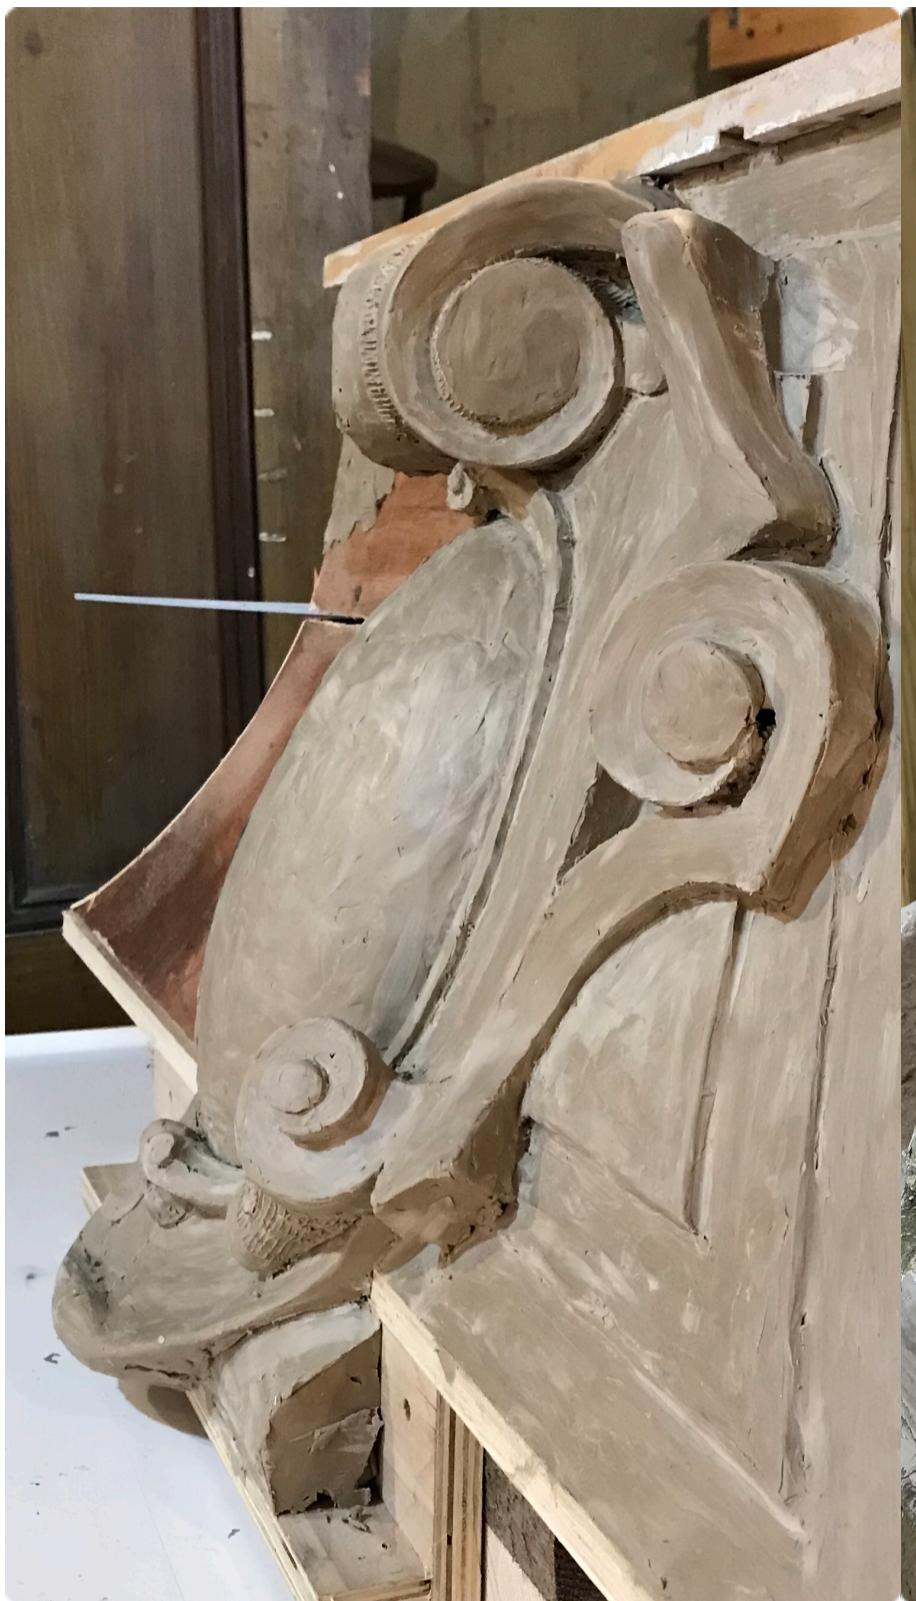
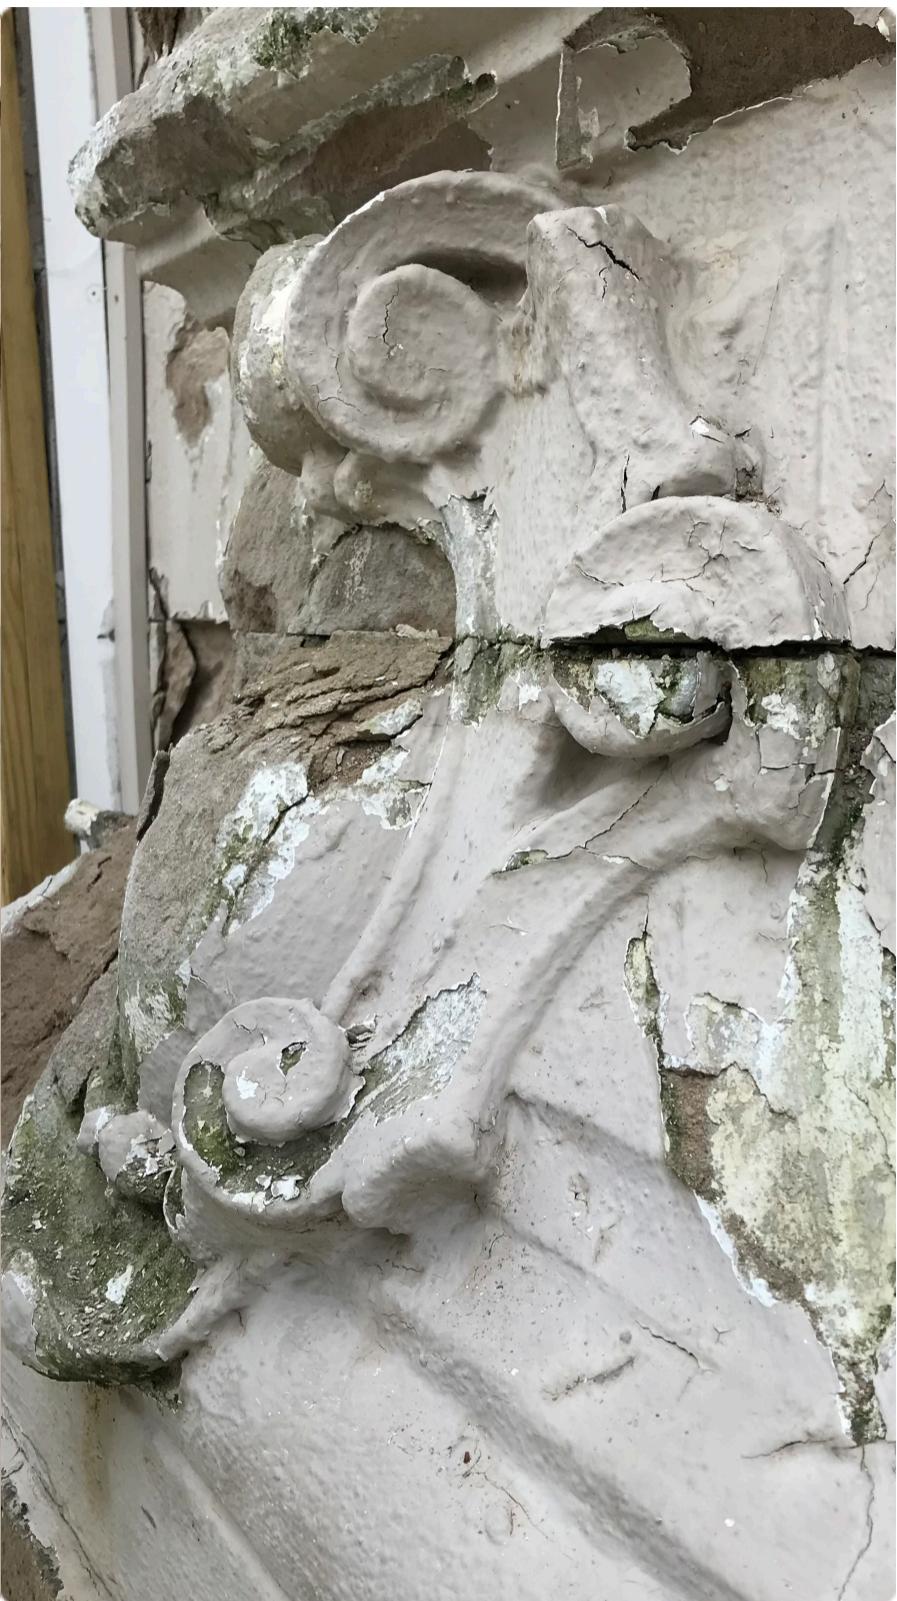
The cartouche maquette was designed based solely on on-site measurements. The construction of one half of the maquette provides all required dimensions and profiles for the complete carving.

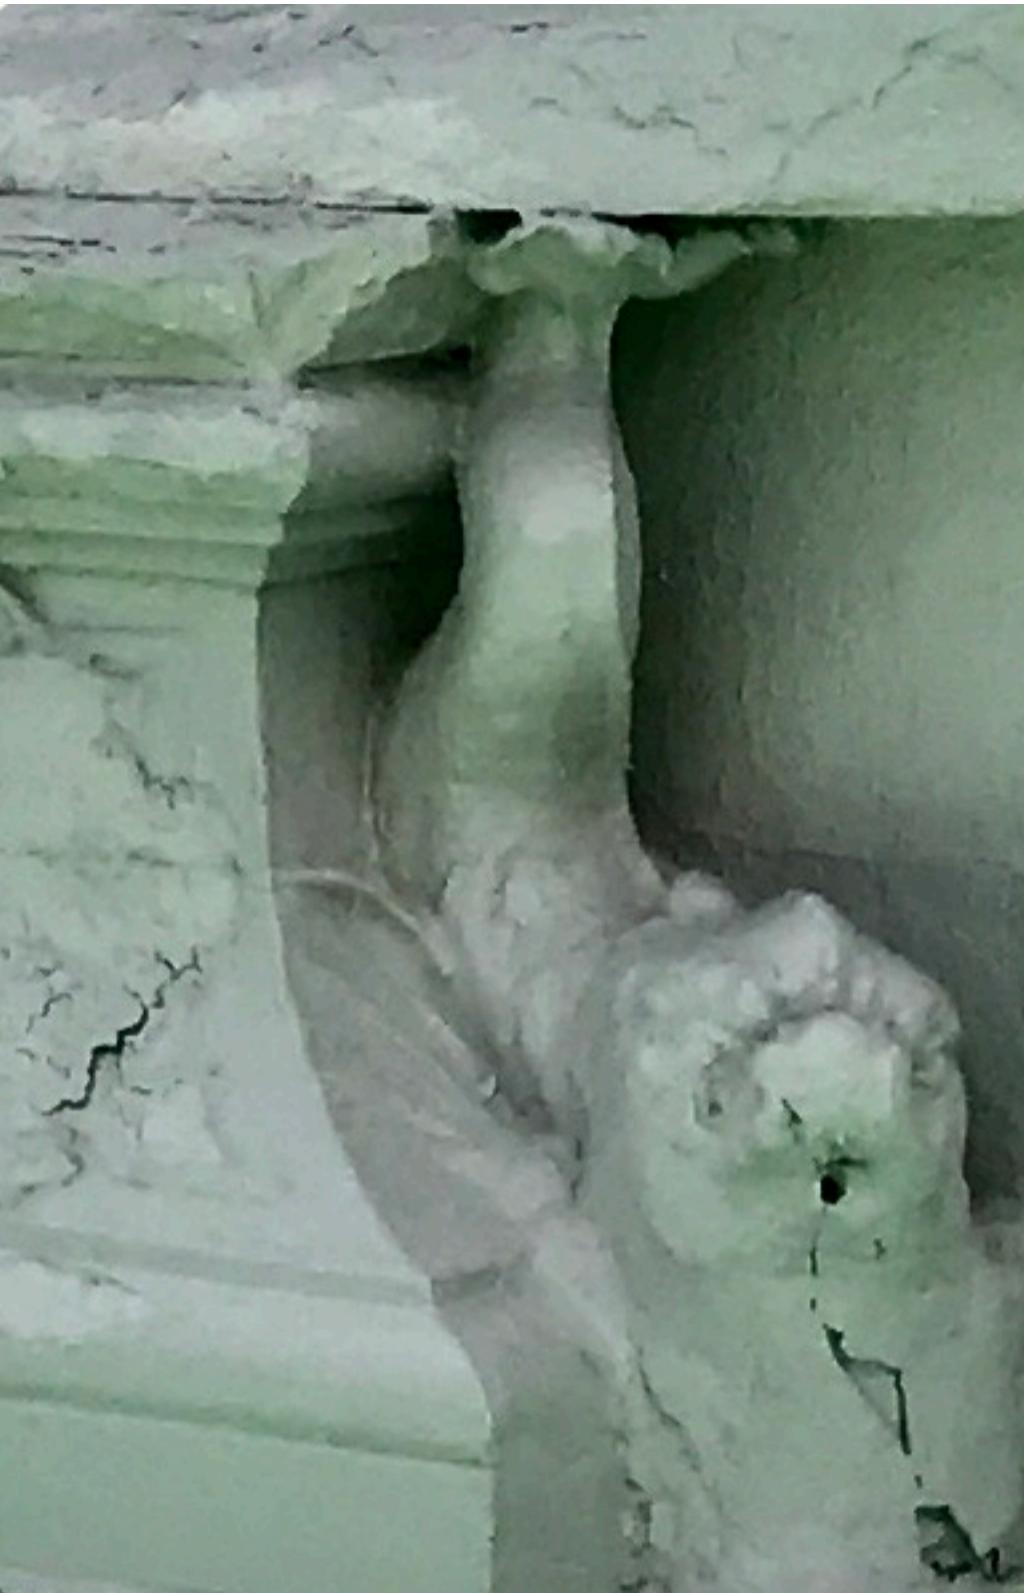
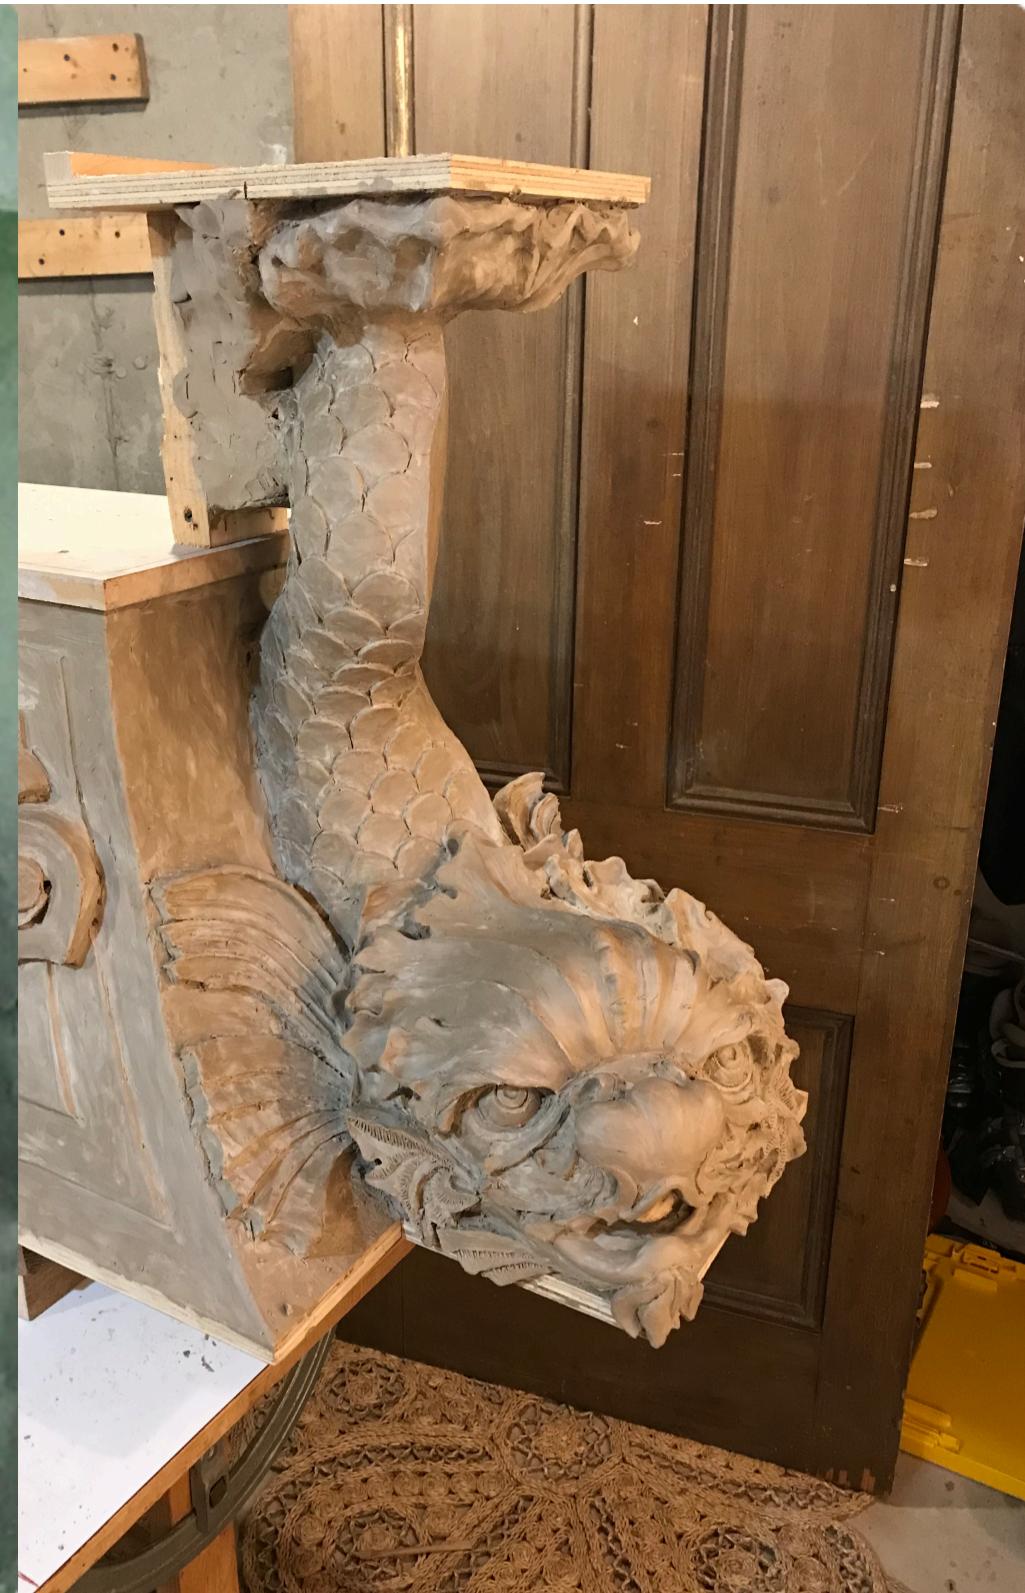
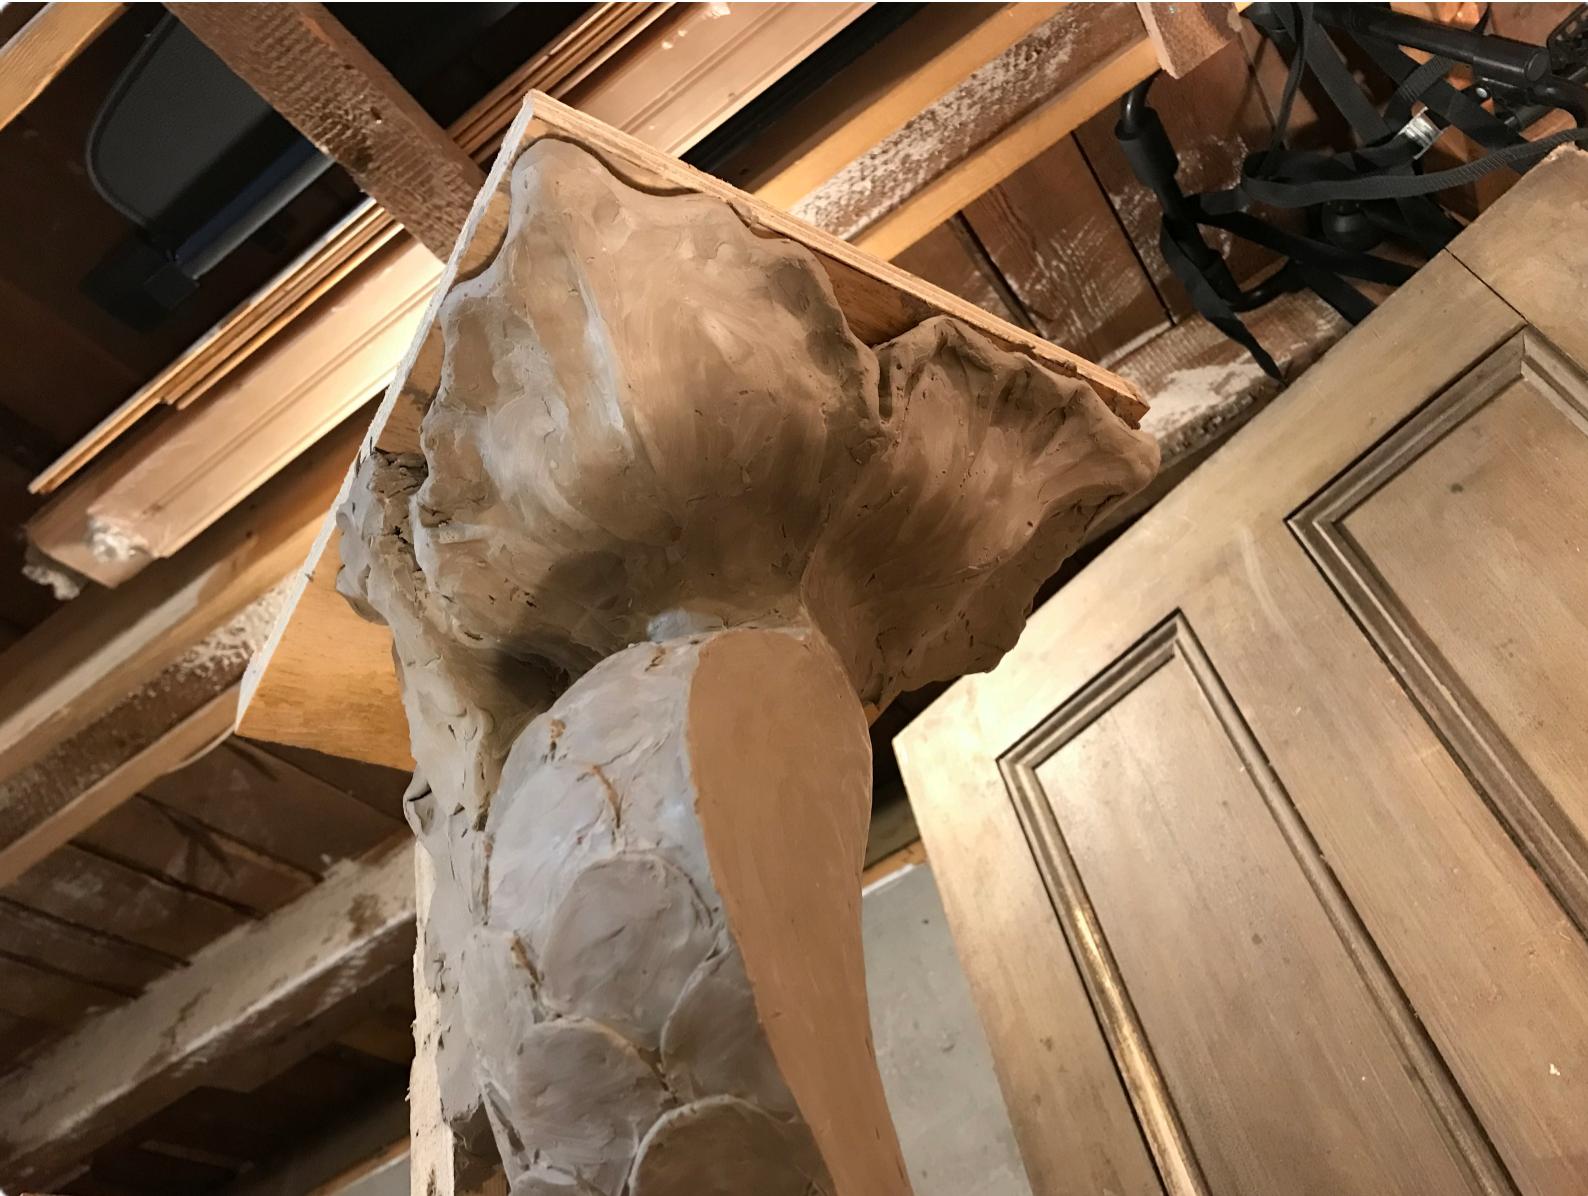
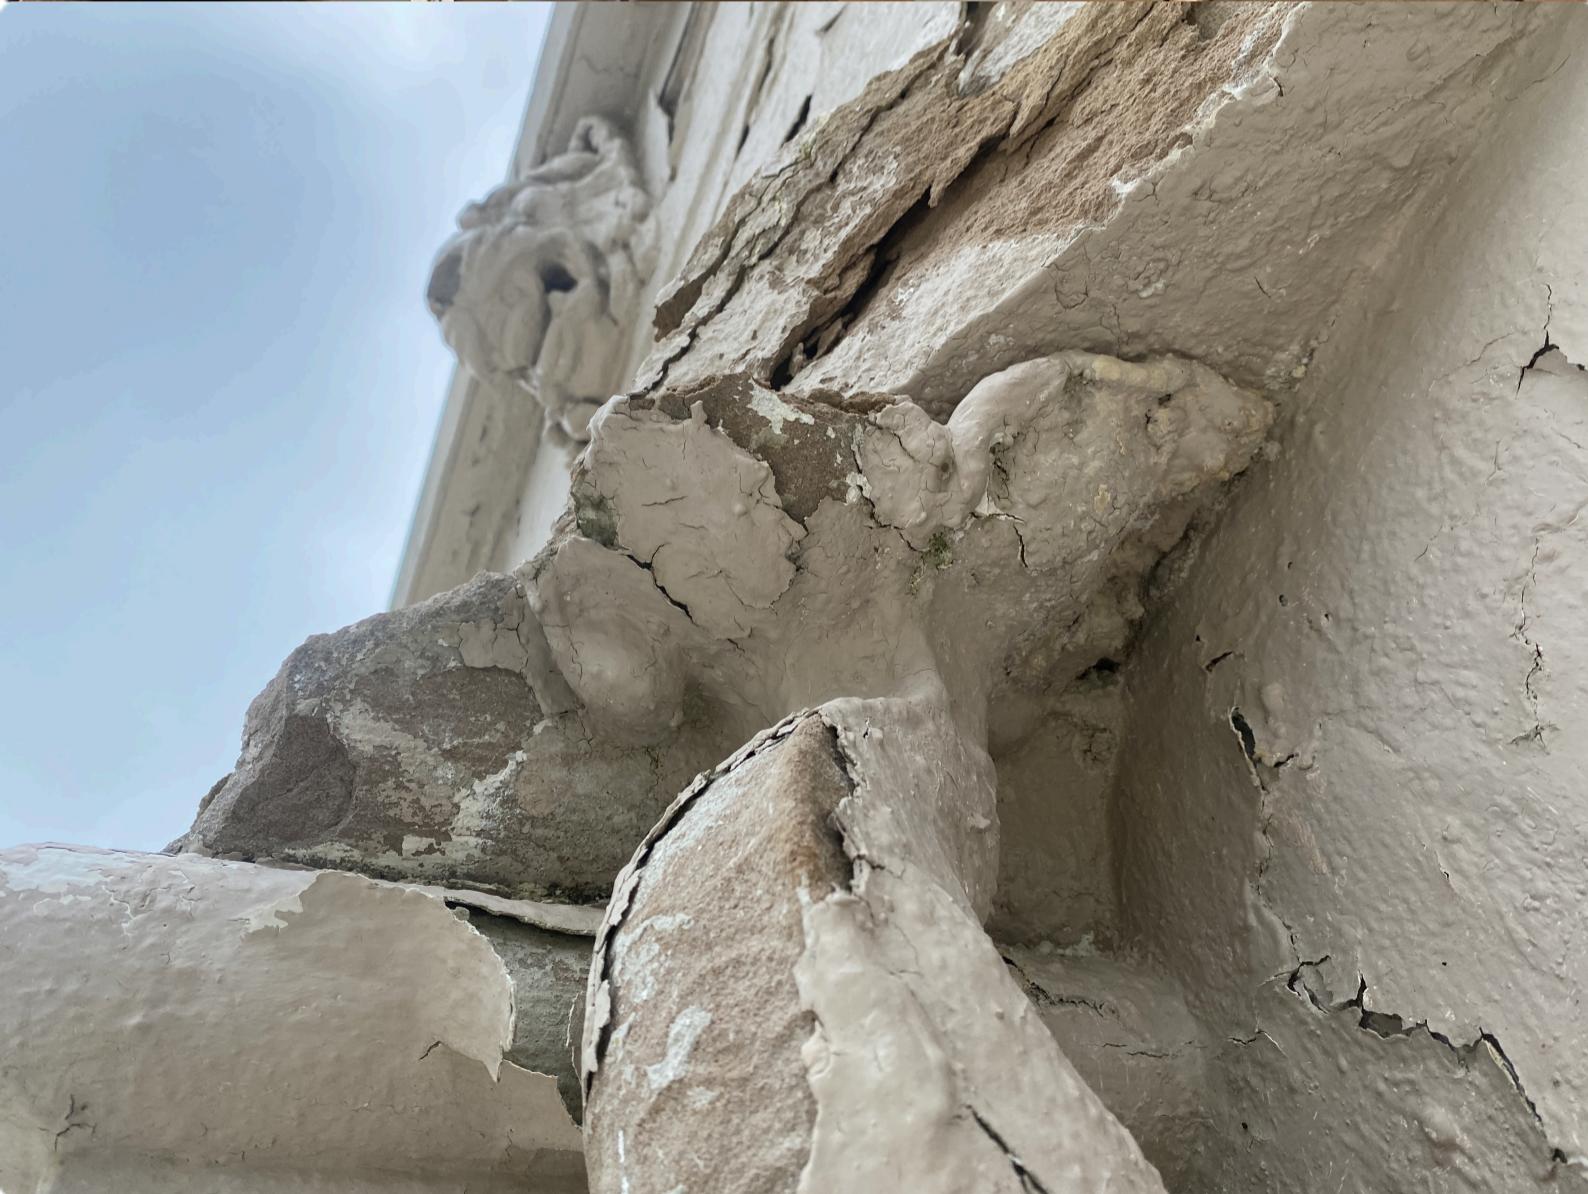
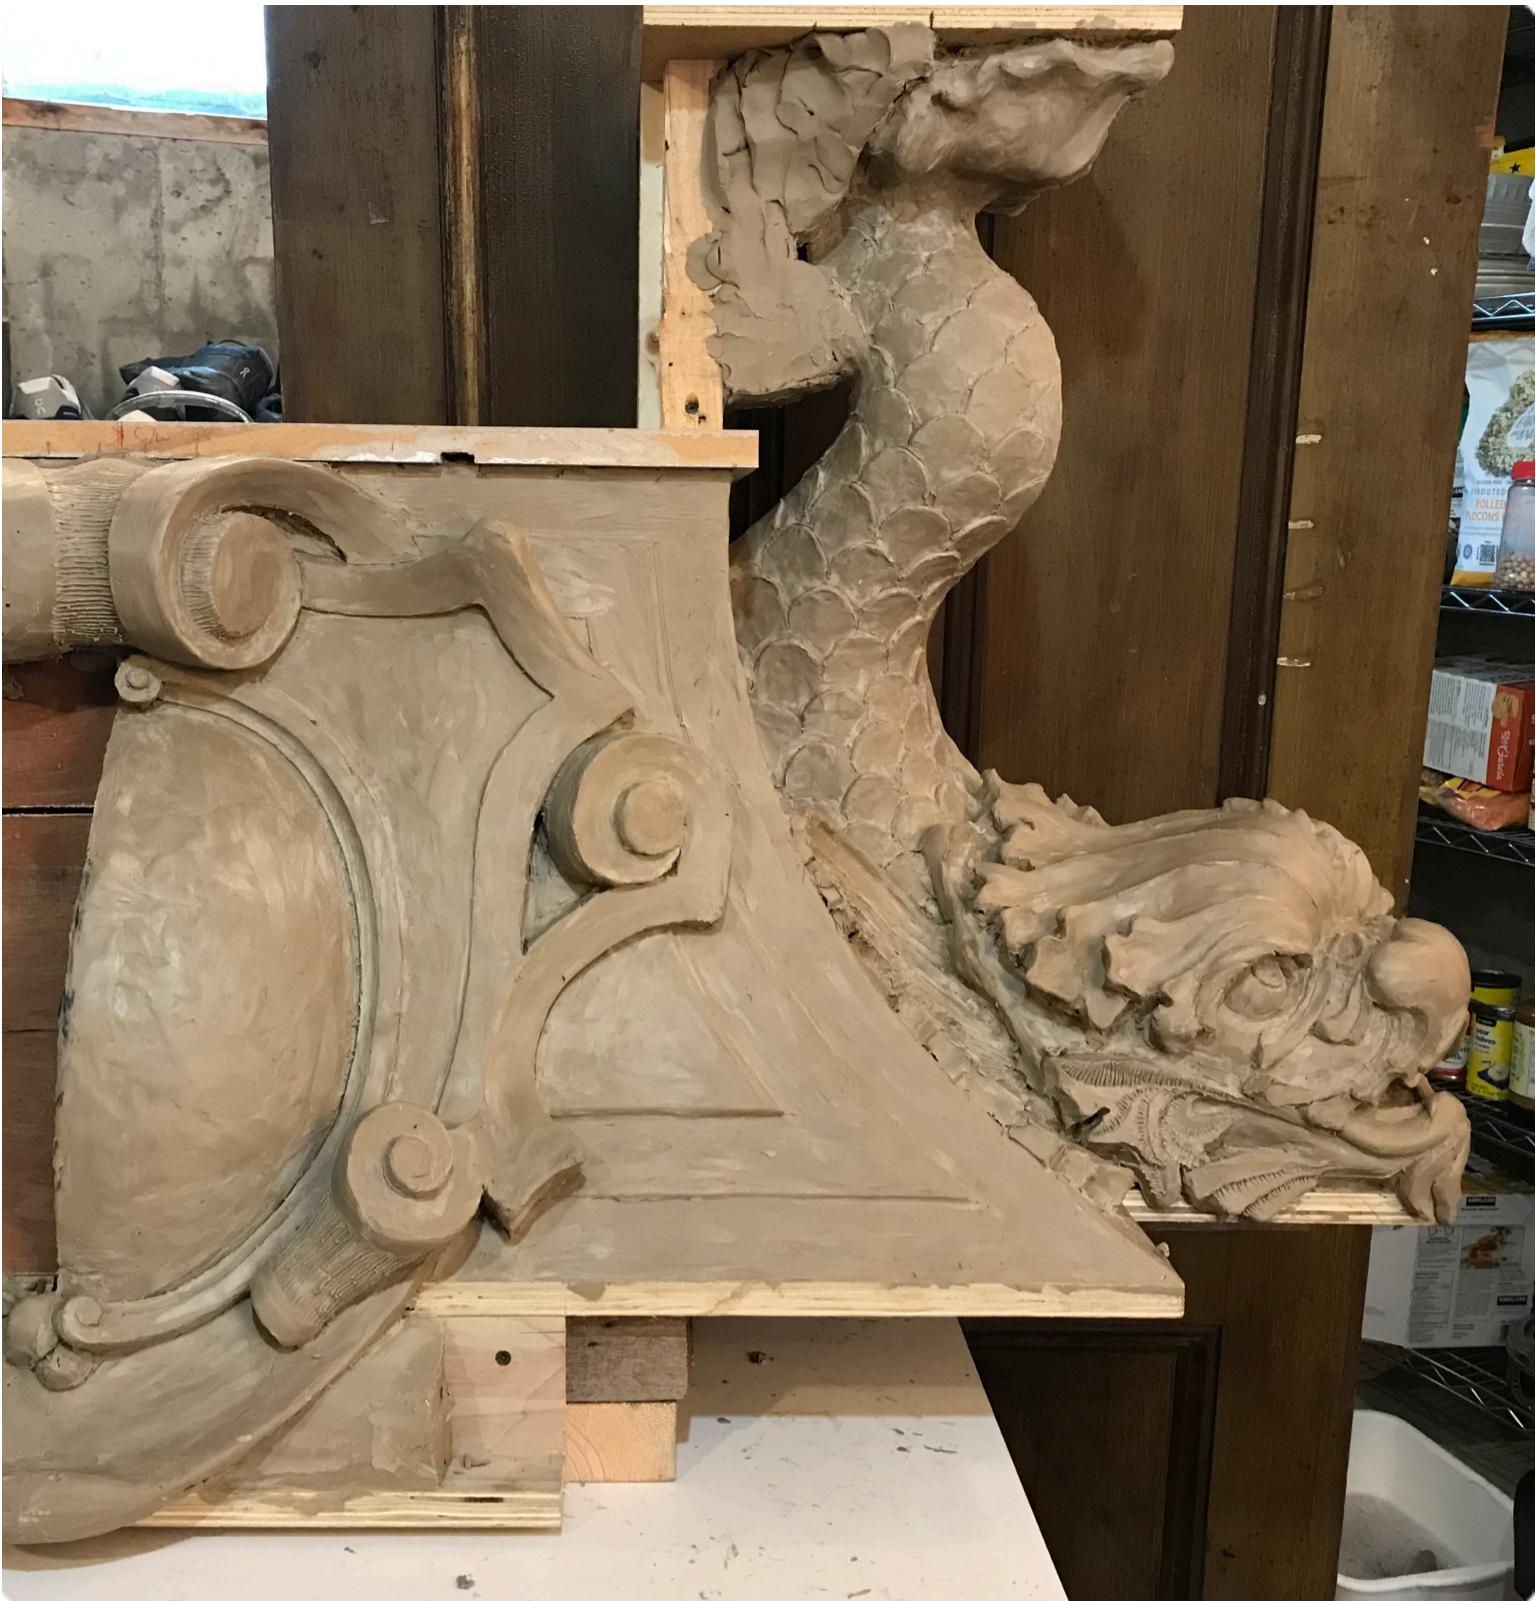
*The historical reference photo has been adjusted to highlight the shadows of the nostrils, dorsal fin, and some ornament on the snout and upper lip. The lower lip and jaw is entirely deteriorated.*
