Hennessy Hall

# Carved Elements - Design Proposal

**Prepared by Scott Harris, FUNDY STONECRAFT**

**Jan 2, 2023**

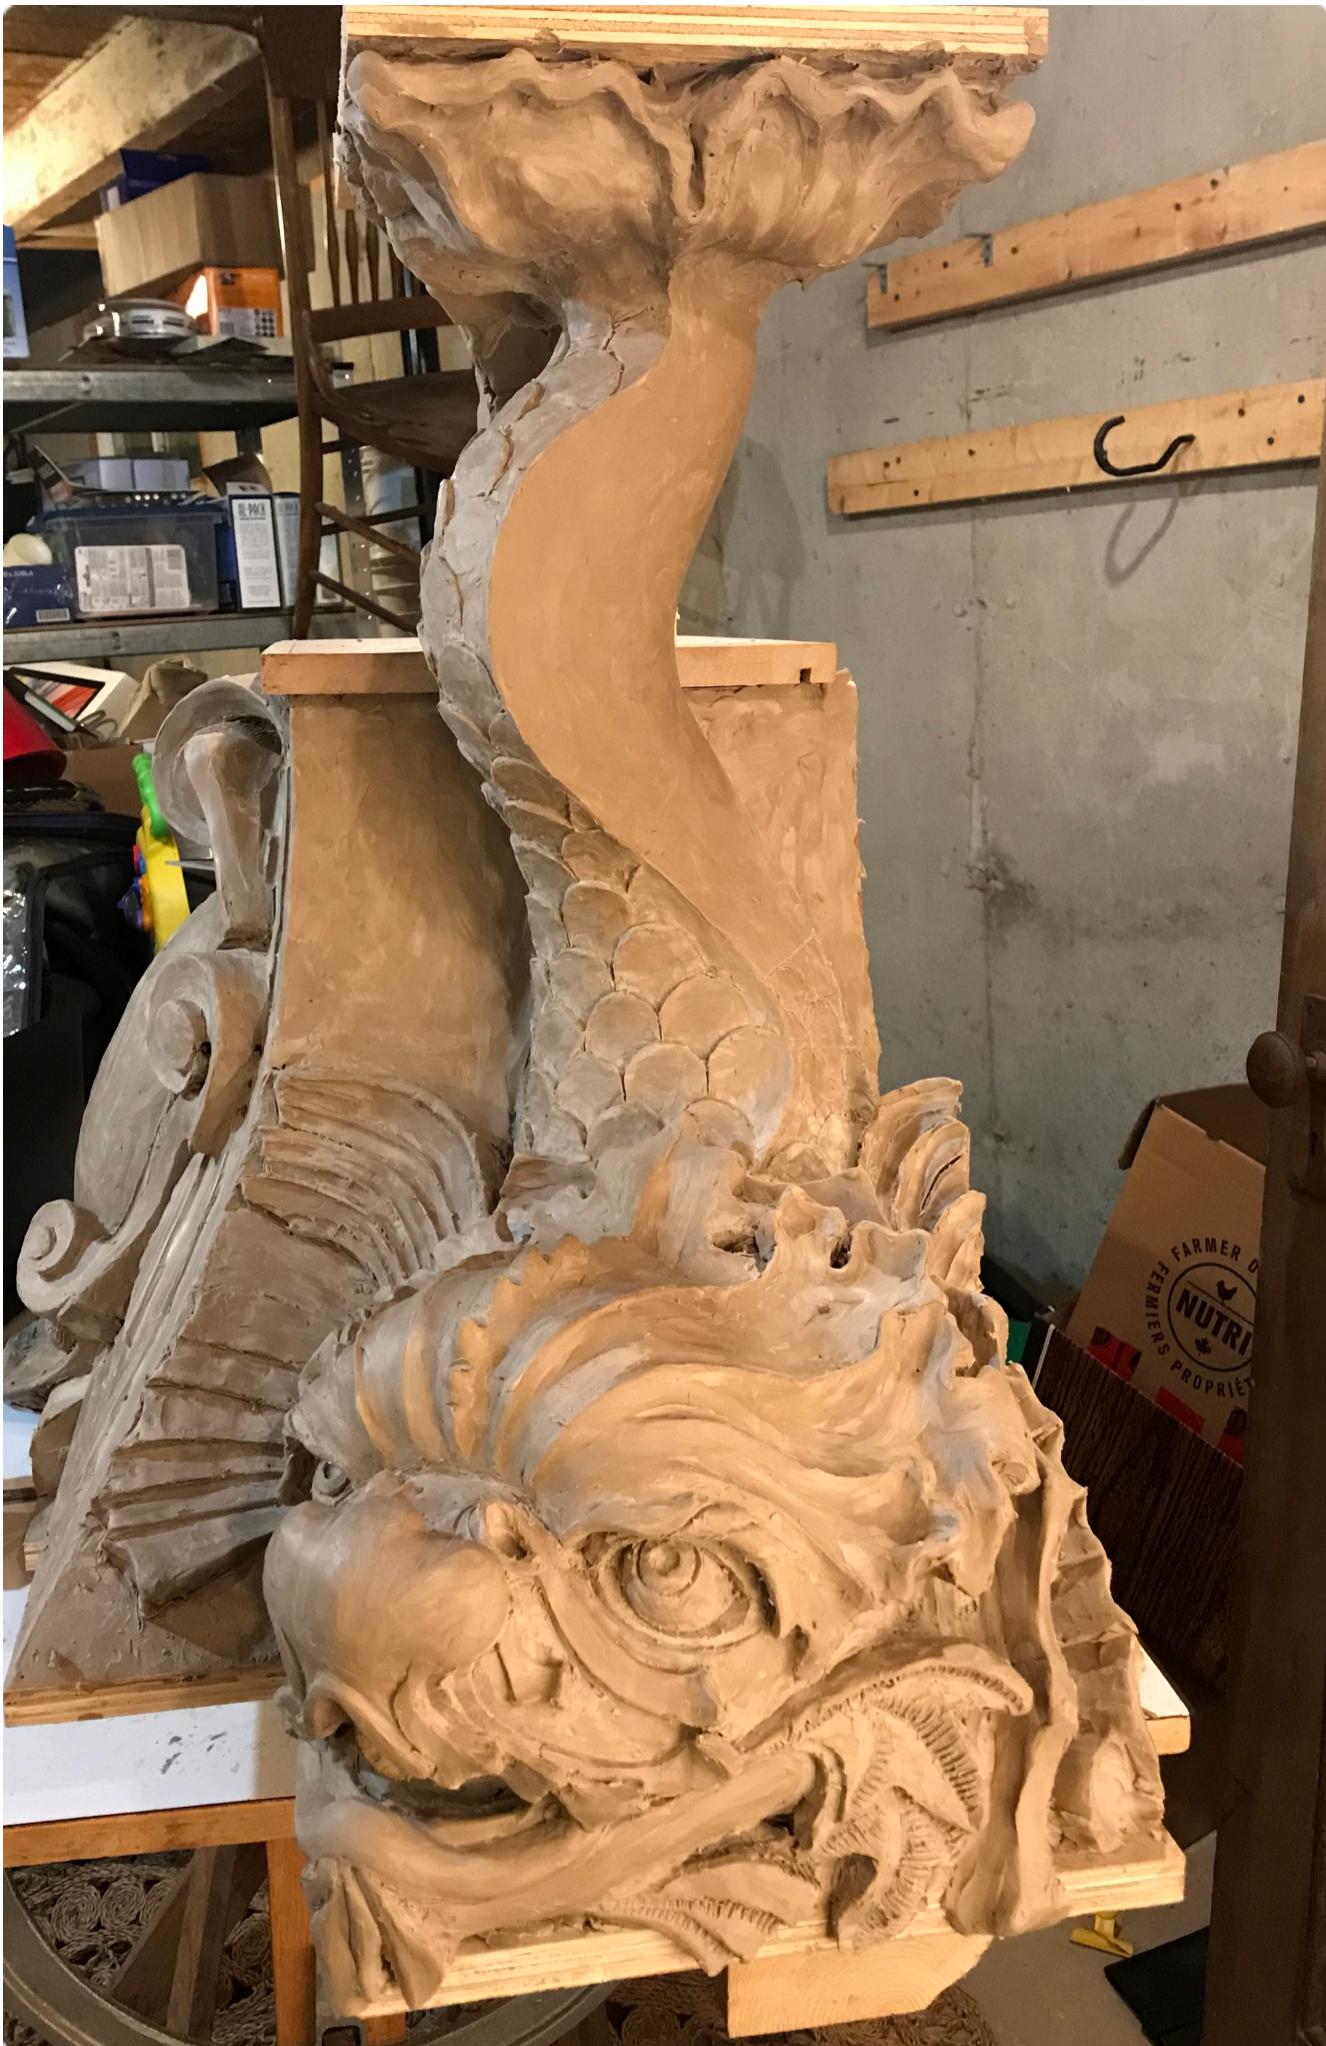
*Right Elevation showing curvature of spine*

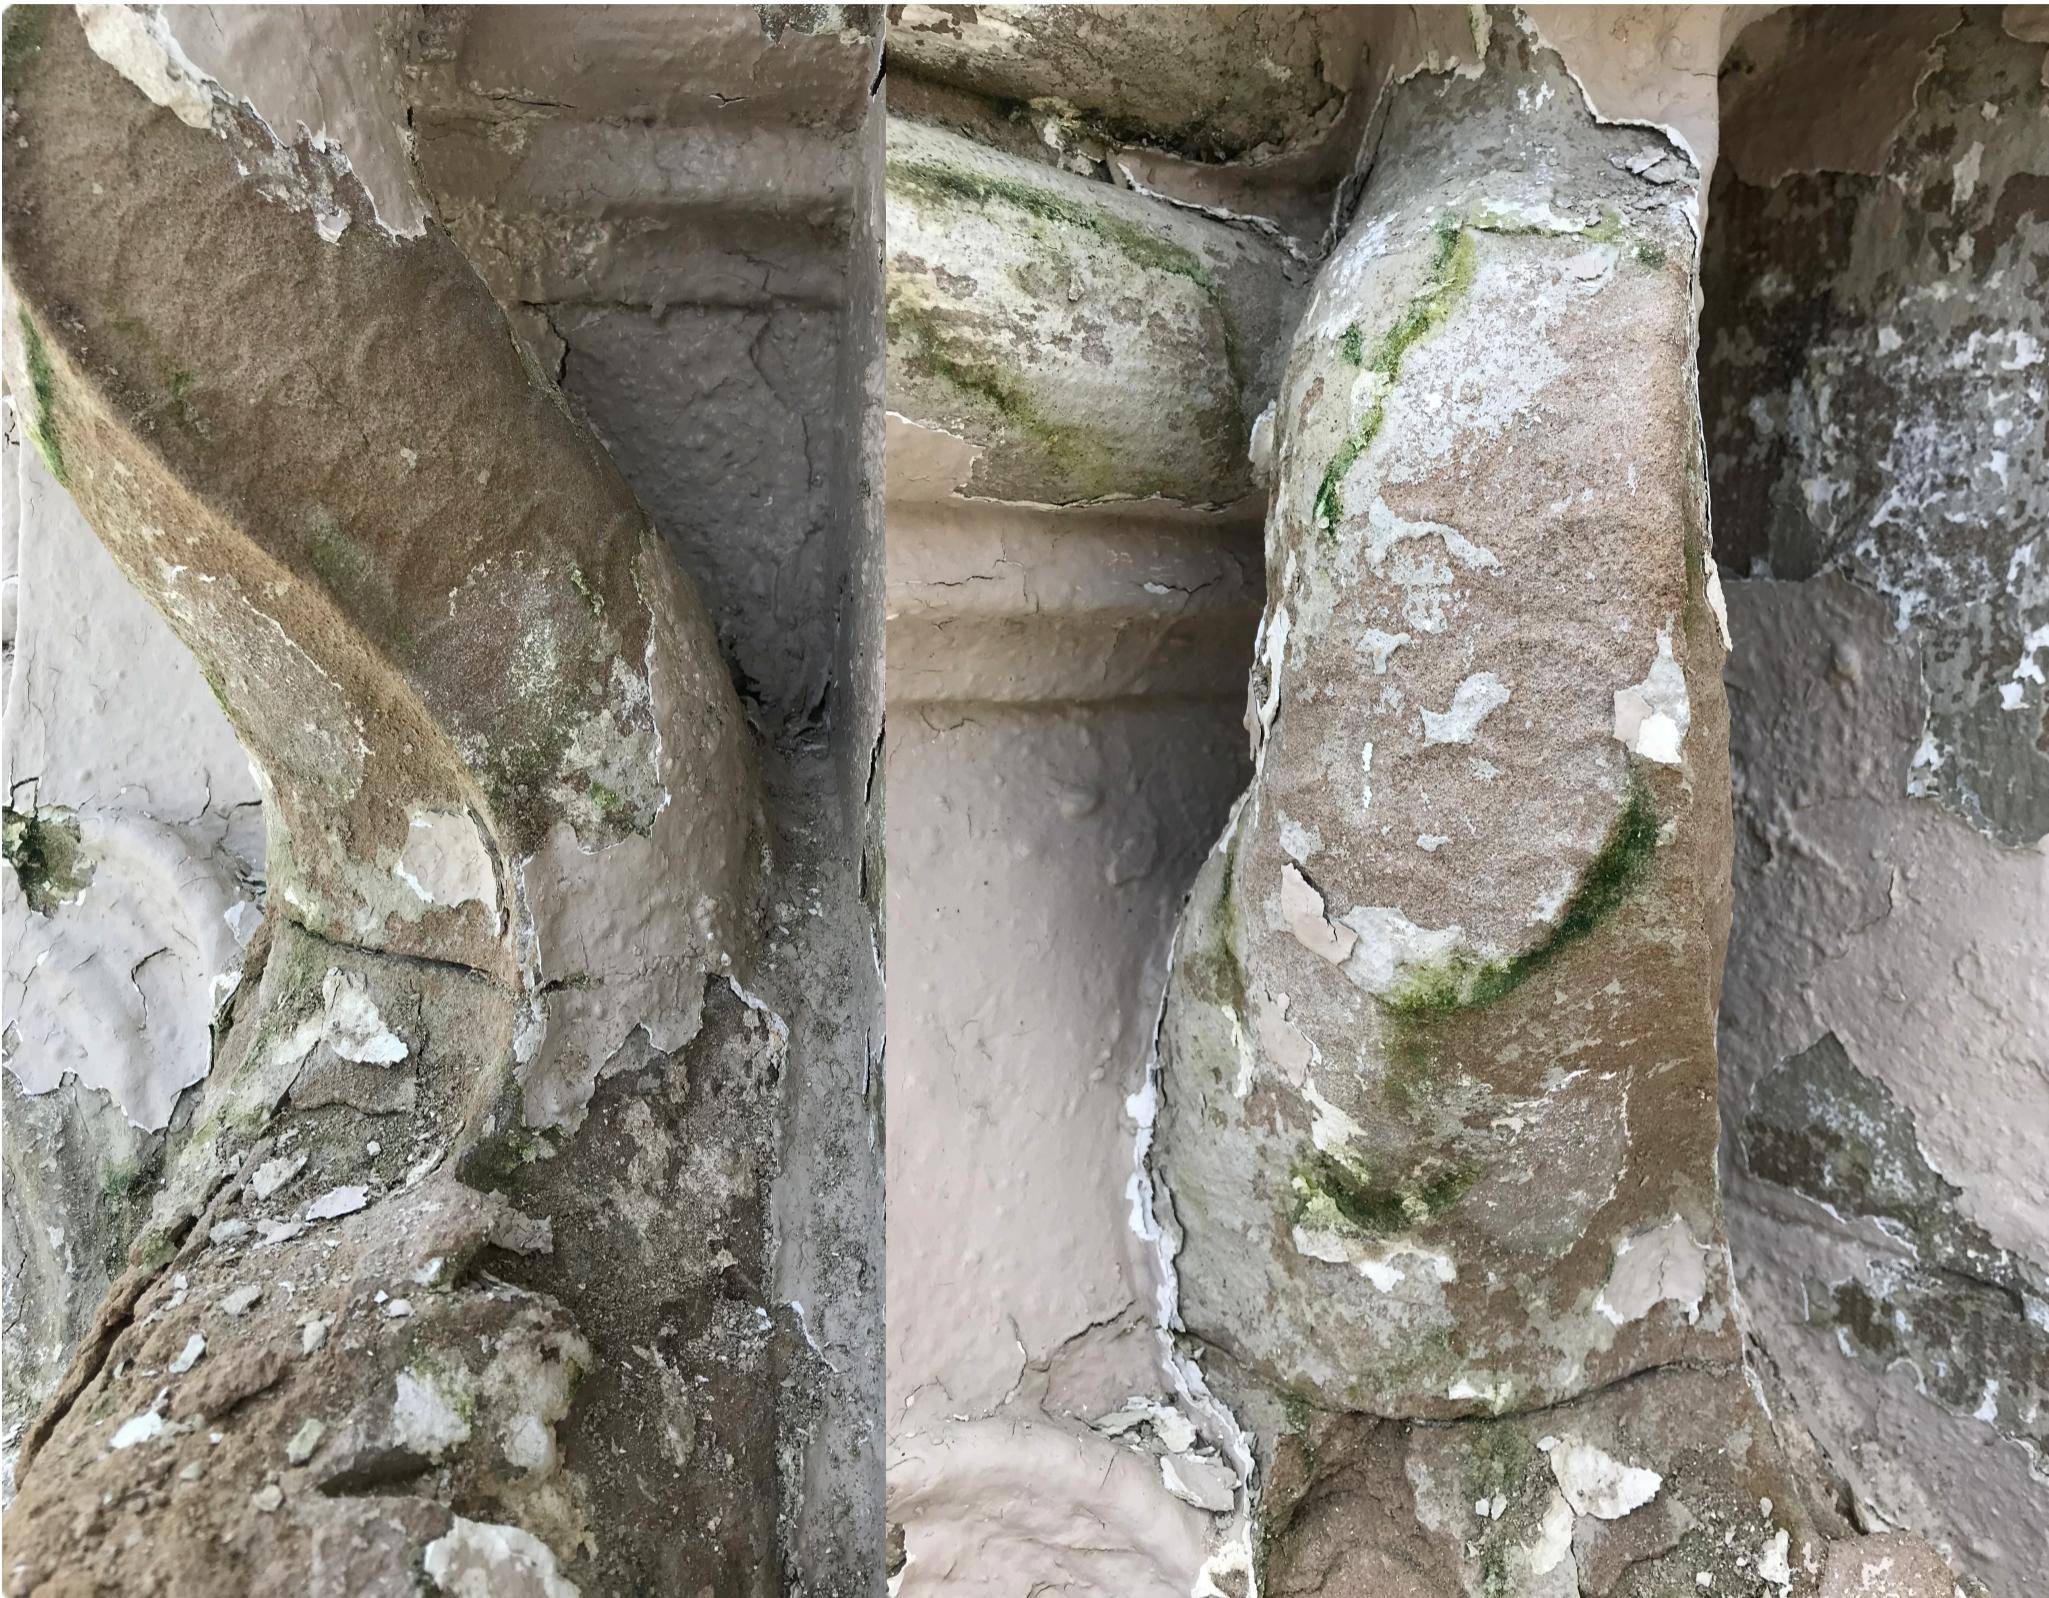
*The fish scales measure approximately 1 1/2" wide by 1' high. They appear as though they had deteriorated prior to the application of the sealant.*

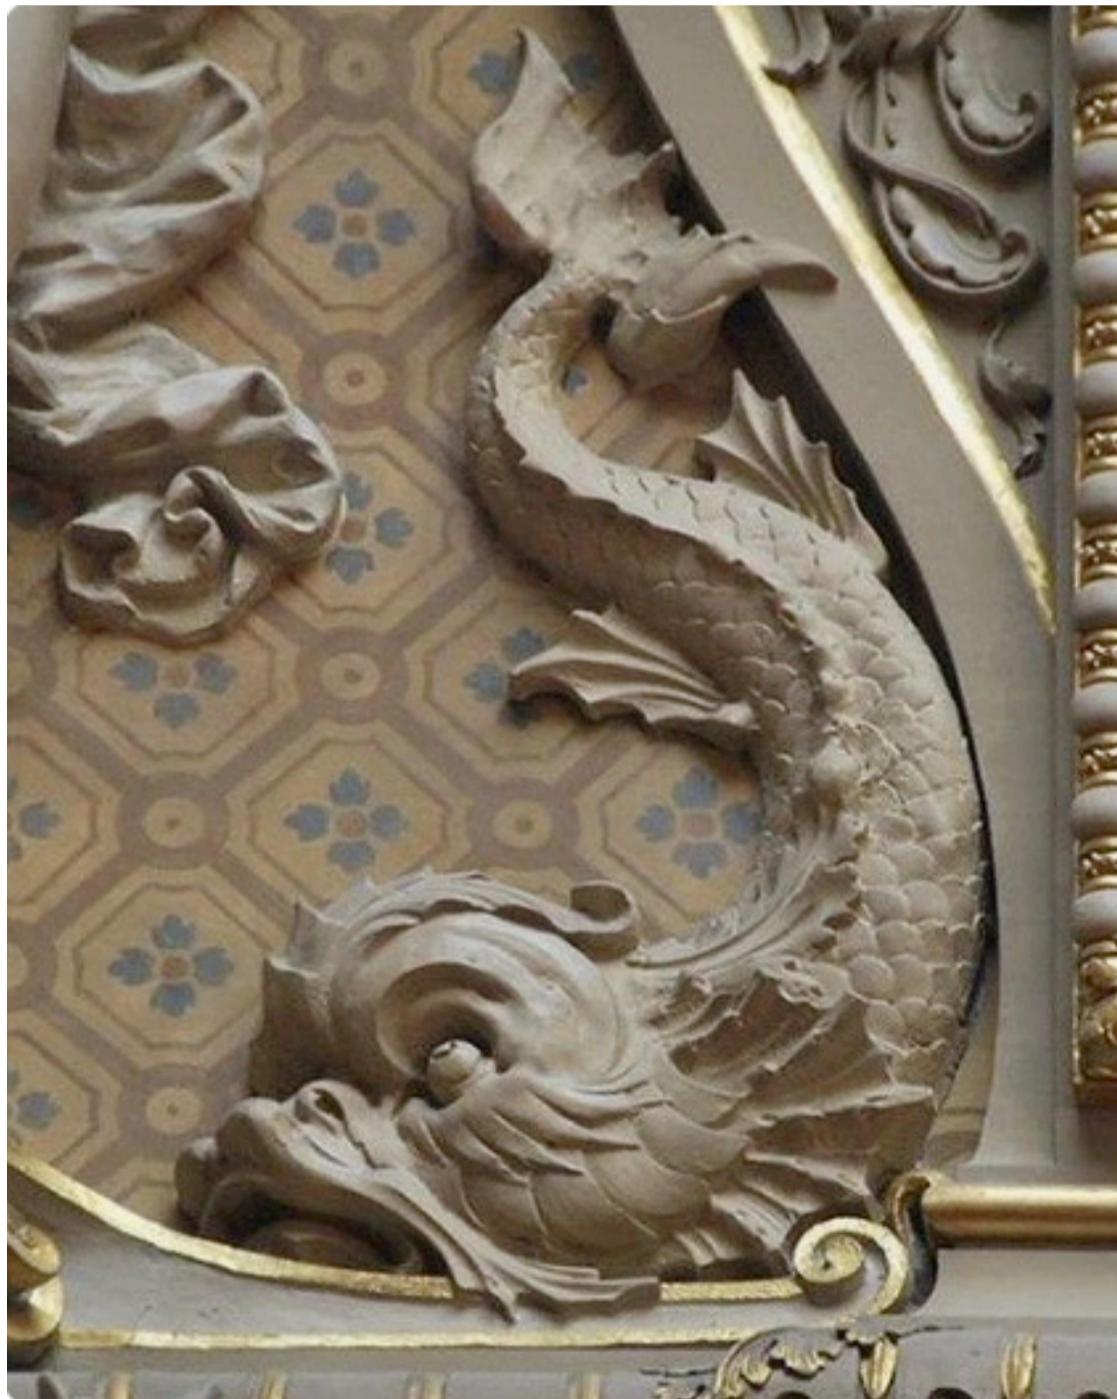
Dorsal Fin, Nostrils, Scales

The remaining details on the original dolphins show small indications of a certain styles that are repeated in many other examples. By identifying common styles of mouth, nostrils, pectoral and dorsal fins and aligning them with the indications of the original, I've approximated the original design without much creativity.

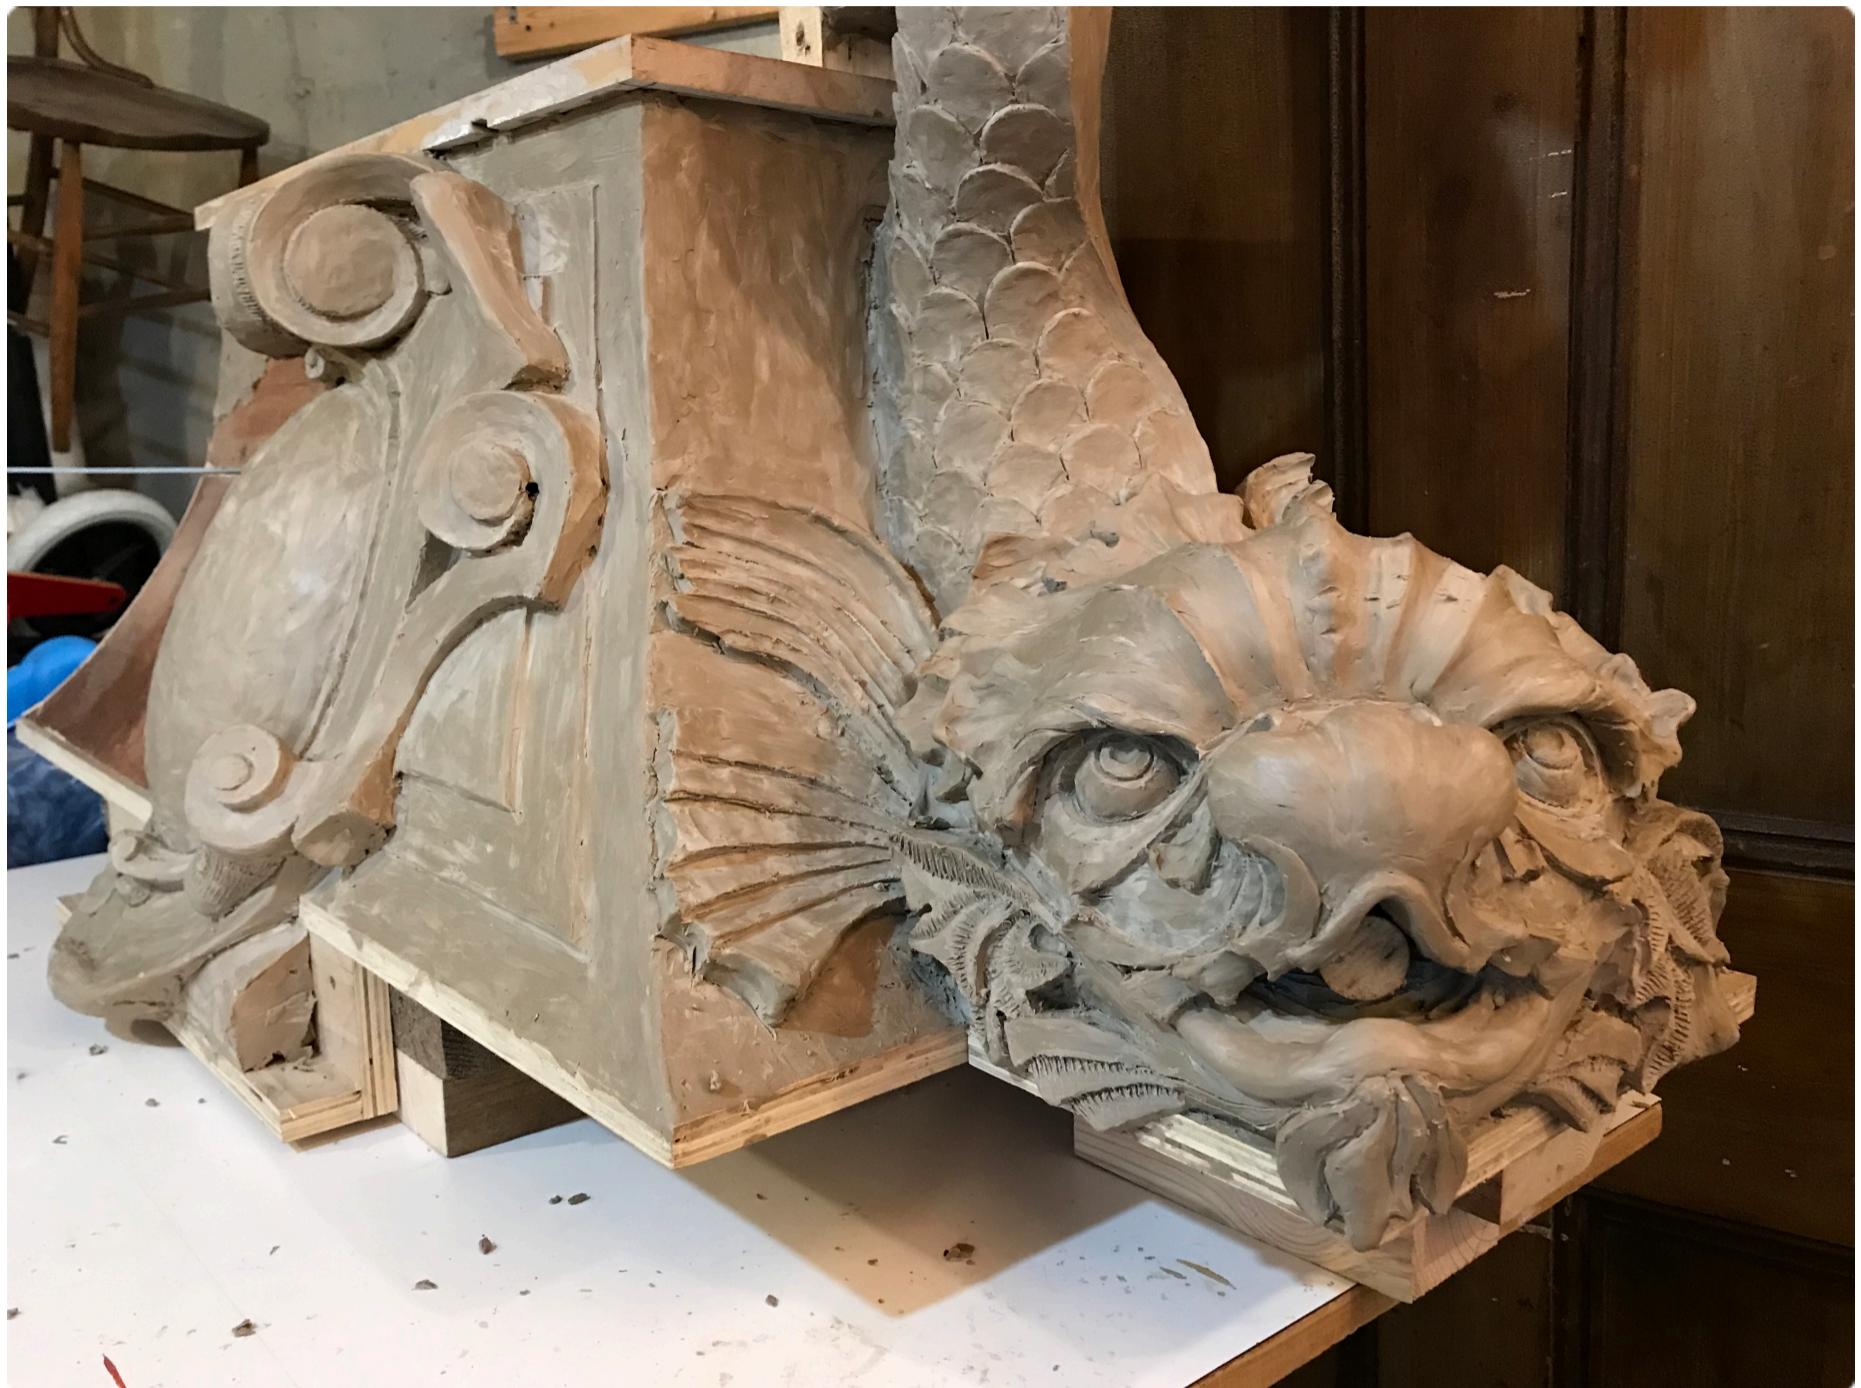
*Showing 1" pipe terminating within dolphins' mouth. I would suggest angling the pipe 2 degrees downward toward the mouth and redirect the water upward out of the mouth with a spout, if possible. This will keep any drips within the mouth, which will drain off the face of the stone.*

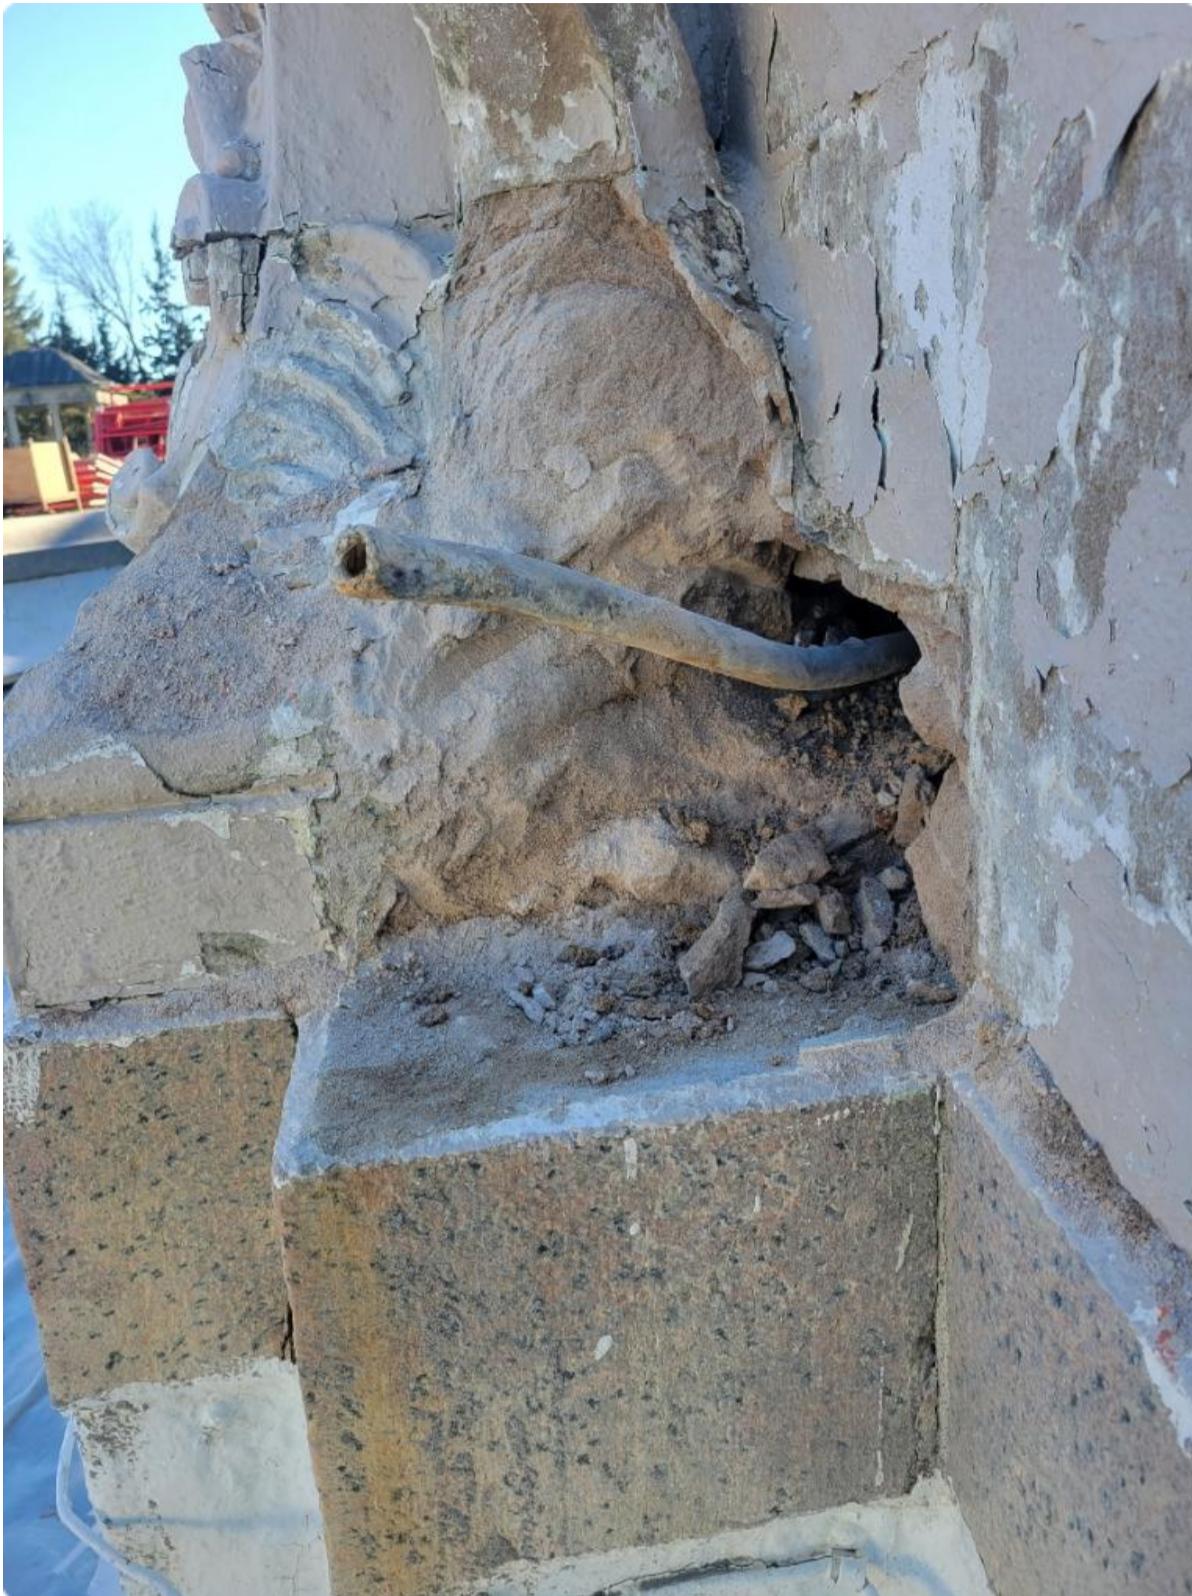
*The original water lines were 1" exterior diameter and sloped about 30 degree upward toward the spout. Considering that the Lion's Head had a spout formed into the pipe, it is possible that this pipe also originally had a spout to spray or angle the water to the desired effect.*
